Access Compliance Report

Public Rights-of-Way

(Curb Ramps)

| Intersection ID: 15005 | Main Street: ARENA_BV | Cross Street: TELEVISION_PL | Location: E |

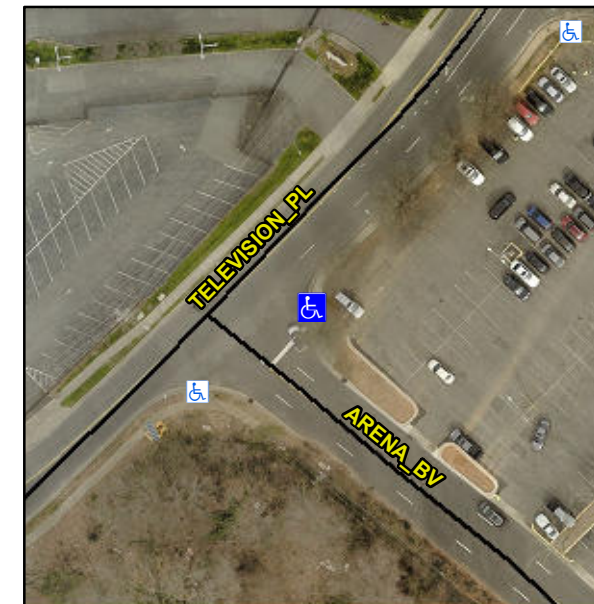
| ADA ID: C4C2CD181EE8 | Ramp Type: Para | Initial Pass/Fail: Fail | Overall Compliance: No |

LT RP < 5%

R304.3.2

| Compliance | Description | Data | Compliance | Description | Data |
|---|---|---|---|---|---|
| Yes | Ramp Slope LT (%) | 2.1 | No | Ramp Slope RT (%) | 14.9 |

Remove & Replace Entire Ramp.
