Access Compliance Report Public Rights-of-Way (Curb Ramps)

Intersection ID: 10143 Main Street: E_34TH_ST Cross Street: N_DAVIDSON_ST Location: SE

ADA ID: C52048CF54AA Ramp Type: Perp Initial Pass/Fail: Fail Overall Compliance: No Severity Score: 21.25

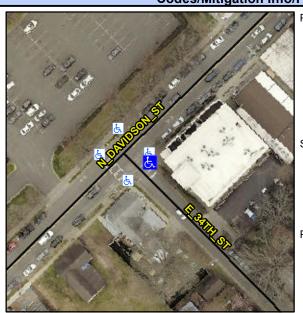
Not Found, R304.5.1, R304.2.2

| Field Measurements/Component Compliance | | | | | |
|---|--|---|---|---|---|
| N/A | Ramp Length (in) | 68.5 | No | Ramp Slope (%) | 9.3 |
| No | Ramp Width (in) | 46.0 | Yes | Ramp XSlope (%) | 0.1 |

Remove & Replace Entire Ramp.
