# Access Compliance Report

## Public Rights-of-Way

### (Curb Ramps)

Intersection ID: 10876	Main Street: DALTON_AV	Cross Street: ASHBY_ST	Location: SE
ADA ID: C52F57DA0D29	Ramp Type: PerpDiag	Initial Pass/Fail: Fail	Overall Compliance: No
Severity Score: 26.25			
Codes/Mitigation Info/Possible Solution		Field Measurements/Component Compliance

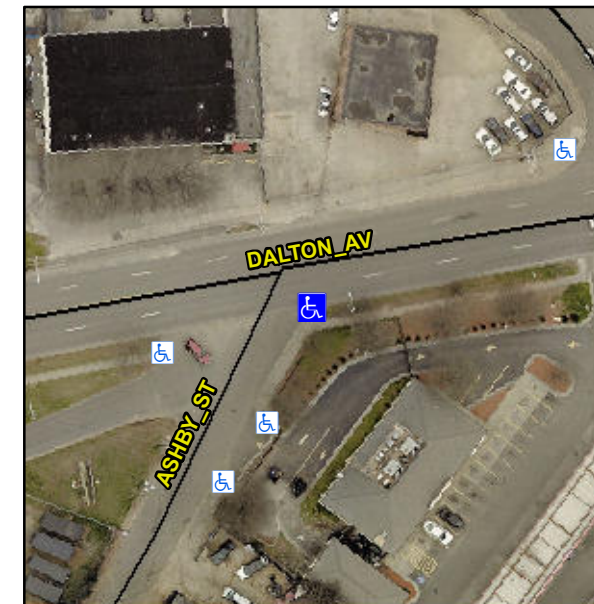
**R304.2.2, R304.5.3**

Compliance	Description	Data	Compliance	Description	Data
N/A	Ramp Length (in)	42.0	No	Ramp Slope (%)	14.3
Yes	Ramp Width (in)	48.0	No	Ramp XSlope (%)	2.7
N/A	Flare Type LT	N/A	N/A	Flare Type RT	N/A
N/A	Flare Slope LT (%)	N/A	N/A	Flare Slope RT (%)	N/A
N/A	Flare Traversable LT?	N/A	N/A	Flare Traversable RT?	N/A
N/A	Landing Length (in)	N/A	N/A	DWS Provided?	N/A
N/A	Landing Width (in)	N/A	N/A	DWS Contrast?	N/A
N/A	Landing Slope (%)	N/A	N/A	DWS Length (in)	N/A
N/A	Landing X Slope (%)	N/A	N/A	DWS Full Width?	N/A
N/A	Landing Curb? (Y/N)	N/A	N/A	DWS Offset (in)	N/A
N/A	Shared Landing?	N/A			
N/A	Gutter Ponding?	Yes	N/A	Gutter Slope (%)	N/A
N/A	Gutter Lip Ht (in)	N/A	N/A	Gutter X Slope (%)	N/A
N/A	Painted X Walk1?	No	N/A	Painted X Walk2?	No
	X Walk 1 Direction	To N		X Walk 2 Direction	To W
N/A	X Walk 1 Width (in)	N/A	N/A	X Walk 2 Width (in)	N/A
	X Walk 1 Slope (%)	1.3		X Walk 2 Slope (%)	0.9
	X Walk 1 X Slope (%)	0.3		X Walk 2 X Slope (%)	3.5

**Remove & Replace Curb Ramp With Two New Directional Ramps or Equivalent.**

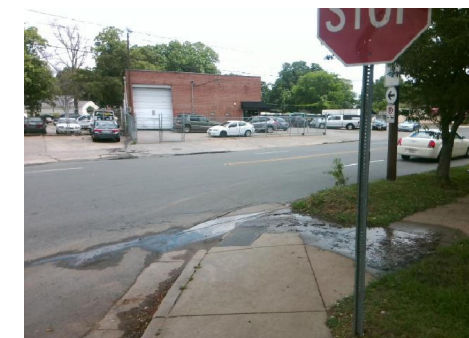
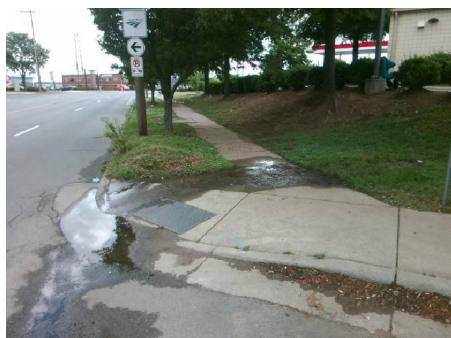
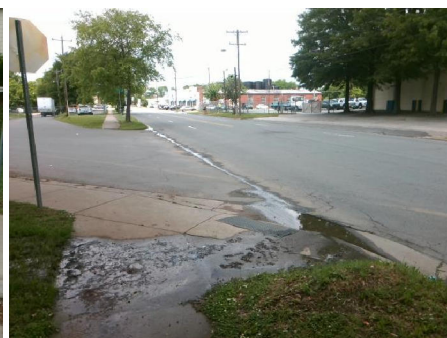
N/A	Ramp inside XWalk1?	N/A	N/A	Ramp inside XWalk2?	N/A
	Road Slope (%)	1.1	N/A	Clear Space?	N/A
	Road X Slope (%)	1.7	N/A	Clear Space to XWalk (in)	N/A
N/A	Any Obstructions?	N/A	N/A	Storm Grate/Utility Hazard?	N/A
	Obstruction Type			Storm Grate/Utility Type	
		N/A			N/A
		Yes		Surface Condition? (G/P)	Good
