Access Compliance Report

Public Rights-of-Way

(Curb Ramps)

Intersection ID: 46488	Main Street: LAUDER_CT	Cross Street: BALLYBAY_DR	Location: SE
ADA ID: C53274B37BD1	Ramp Type: Perp	Initial Pass/Fail: Pass	Overall Compliance: No
Severity Score: 0			
Codes/Mitigation Info/Possible Solution		Field Measurements/Component Compliance

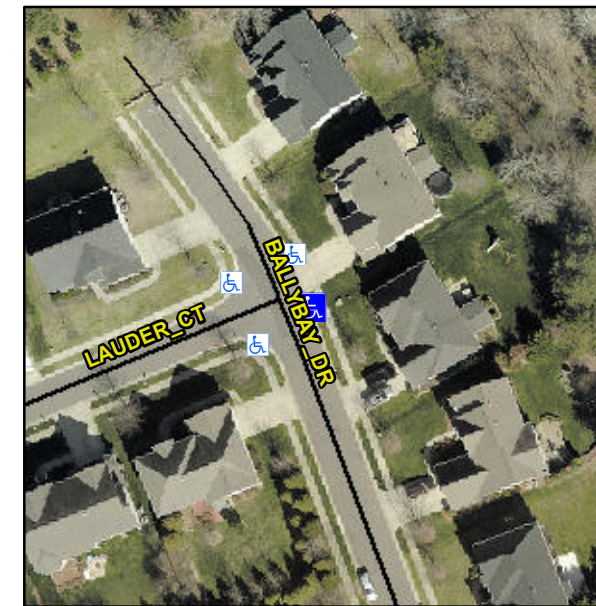
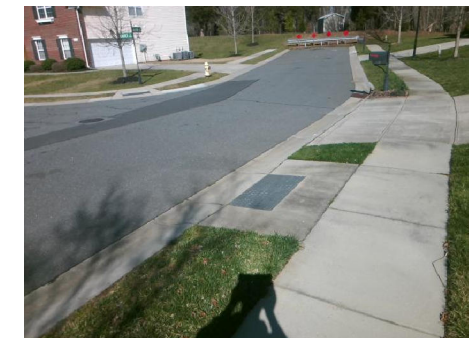
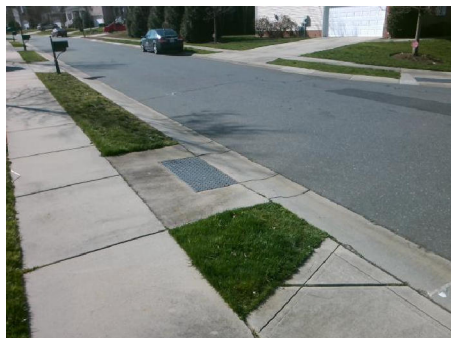
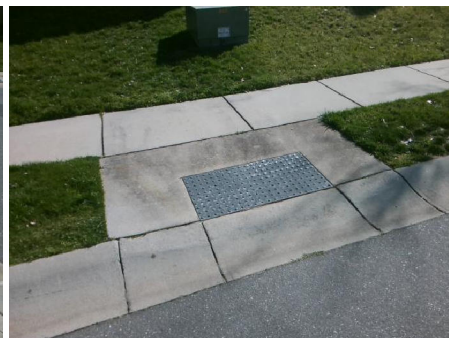
Not Found, R304.2.1

Compliance	Description	Data	Compliance	Description	Data
N/A	Ramp Length (in)	48.0	Yes	Ramp Slope (%)	6.6
Yes	Ramp Width (in)	48.0	Yes	Ramp XSlope (%)	1.1
N/A	Flare Type LT	Sloped	N/A	Flare Type RT	N/A
N/A	Flare Slope LT (%)	2.4	Yes	Flare Slope RT (%)	6.0
N/A	Flare Traversable LT?	Yes	N/A	Flare Traversable RT?	Yes
No	Landing Length (in)	47.0	Yes	DWS Provided?	Yes
Yes	Landing Width (in)	48.0	Yes	DWS Contrast?	Yes
Yes	Landing Slope (%)	1.4	Yes	DWS Length (in)	24.0
Yes	Landing X Slope (%)	0.1	Yes	DWS Full Width?	Yes
N/A	Landing Curb? (Y/N)	No	Yes	DWS Offset (in)	0.0
N/A	Shared Landing?	No			
Yes	Gutter Ponding?	No	Yes	Gutter Slope (%)	0.9
Yes	Gutter Lip Ht (in)	0.0	Yes	Gutter X Slope (%)	1.5
N/A	Painted X Walk1?	No	N/A	Painted X Walk2?	N/A
	X Walk 1 Direction	To SW		X Walk 2 Direction	N/A
N/A	X Walk 1 Width (in)	N/A	N/A	X Walk 2 Width (in)	N/A
	X Walk 1 Slope (%)	4.7		X Walk 2 Slope (%)	N/A
	X Walk 1 X Slope (%)	2.4		X Walk 2 X Slope (%)	N/A

N/A	Ramp inside XWalk1?	N/A	N/A	Ramp inside XWalk2?	N/A
	Road Slope (%)	N/A	N/A	Clear Space?	Yes
	Road X Slope (%)	N/A	N/A	Clear Space to XWalk (in)	N/A
Yes	Any Obstructions?	No	Yes	Storm Grate/Utility Hazard?	No
	Obstruction Type			Storm Grate/Utility Type	
		N/A			N/A
			Yes	Surface Condition? (G/P)	Good

Remove & Replace Entire Ramp.
