Access Compliance Report Public Rights-of-Way (Curb Ramps)

Intersection ID: 44610	Main Street: FIG_LN	Cross Street: PINYON_PINE_LN	Location: SE
ADA ID: C55D76DB2150	Ramp Type: Perp	Initial Pass/Fail: Pass	Overall Compliance: No Severity Score: 7.5

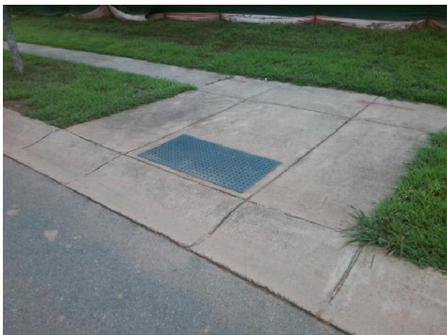
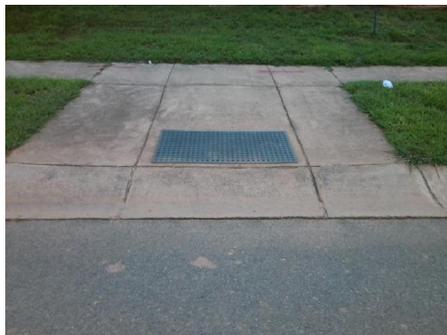
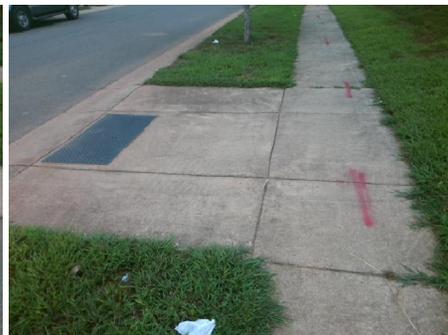
**Not Found, R304.2.1, R305.1.4,
 R305.2, R304.5.4**

Compliance	Description	Data	Compliance	Description	Data
N/A	Ramp Length (in)	84.0	Yes	Ramp Slope (%)	6.9
Yes	Ramp Width (in)	58.0	Yes	Ramp XSlope (%)	1.6
N/A	Flare Type LT	Sloped	N/A	Flare Type RT	N/A
N/A	Flare Slope LT (%)	4.6	N/A	Flare Slope RT (%)	1.2
N/A	Flare Traversable LT?	No	N/A	Flare Traversable RT?	No
No	Landing Length (in)	47.0	Yes	DWS Provided?	Yes
Yes	Landing Width (in)	58.0	Yes	DWS Contrast?	Yes
Yes	Landing Slope (%)	1.6	Yes	DWS Length (in)	25.5
Yes	Landing X Slope (%)	0.6	No	DWS Full Width?	No
N/A	Landing Curb? (Y/N)	No	No	DWS Offset (in)	2.5
N/A	Shared Landing?	Yes			
Yes	Gutter Ponding?	No	No	Gutter Slope (%)	5.1
Yes	Gutter Lip Ht (in)	0.0	Yes	Gutter X Slope (%)	1.9
N/A	Painted X Walk1?	No	N/A	Painted X Walk2?	N/A
	X Walk 1 Direction	To N		X Walk 2 Direction	N/A
N/A	X Walk 1 Width (in)	N/A	N/A	X Walk 2 Width (in)	N/A
	X Walk 1 Slope (%)	2.0		X Walk 2 Slope (%)	N/A
	X Walk 1 X Slope (%)	1.4		X Walk 2 X Slope (%)	N/A

N/A	Ramp inside XWalk1?	N/A	N/A	Ramp inside XWalk2?	N/A
	Road Slope (%)	N/A	N/A	Clear Space?	Yes
	Road X Slope (%)	N/A	N/A	Clear Space to XWalk (in)	N/A
Yes	Any Obstructions?	No	Yes	Storm Grate/Utility Hazard?	No
	Obstruction Type			Storm Grate/Utility Type	
		N/A			N/A
			Yes	Surface Condition? (G/P)	Good

Possible Solutions:
**Remove & Replace Entire Ramp.
 Remove & Replace Gutter.**
