Intersection ID: 42559	Main Street: ENEIDA_SUE_DR	Cross Street: LUNDY_LN	Location:	S
ADA ID: C576C0493ED4	Ramp Type: Perp	Initial Pass/Fail: Fail	Overall Compliance: No	Severity Score: 22.5

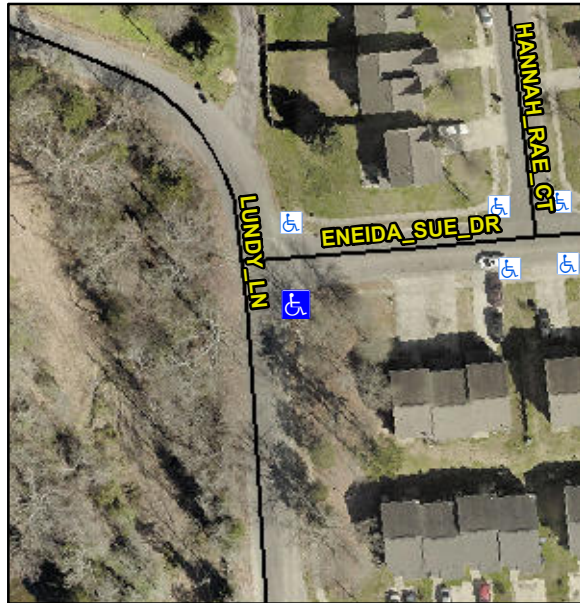
**Not Found, R304.5.1, R304.2.2,
R304.5.3**

Compliance	Description	Data	Compliance	Description	Data
N/A	Ramp Length (in)	48.5	No	Ramp Slope (%)	8.4
No	Ramp Width (in)	44.0	No	Ramp XSlope (%)	3.9
N/A	Flare Type LT	N/A	N/A	Flare Type RT	N/A
N/A	Flare Slope LT (%)	N/A	N/A	Flare Slope RT (%)	N/A
N/A	Flare Traversable LT?	N/A	N/A	Flare Traversable RT?	N/A
N/A	Landing Length (in)	N/A	N/A	DWS Provided?	N/A
N/A	Landing Width (in)	N/A	N/A	DWS Contrast?	N/A
N/A	Landing Slope (%)	N/A	N/A	DWS Length (in)	N/A
N/A	Landing X Slope (%)	N/A	N/A	DWS Full Width?	N/A
N/A	Landing Curb? (Y/N)	N/A	N/A	DWS Offset (in)	N/A
N/A	Shared Landing?	N/A			
N/A	Gutter Ponding?	N/A	N/A	Gutter Slope (%)	N/A
N/A	Gutter Lip Ht (in)	N/A	N/A	Gutter X Slope (%)	N/A
N/A	Painted X Walk1?	No	N/A	Painted X Walk2?	N/A
	X Walk 1 Direction	To N		X Walk 2 Direction	N/A
N/A	X Walk 1 Width (in)	N/A	N/A	X Walk 2 Width (in)	N/A
	X Walk 1 Slope (%)	4.5		X Walk 2 Slope (%)	N/A
	X Walk 1 X Slope (%)	2.4		X Walk 2 X Slope (%)	N/A

Remove & Replace Entire Ramp.

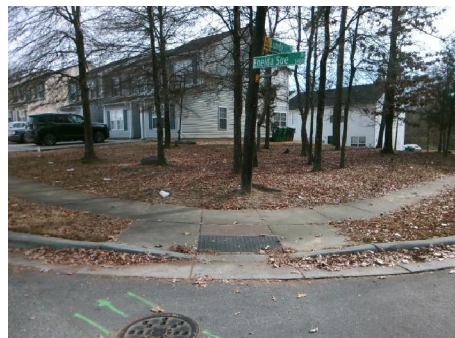
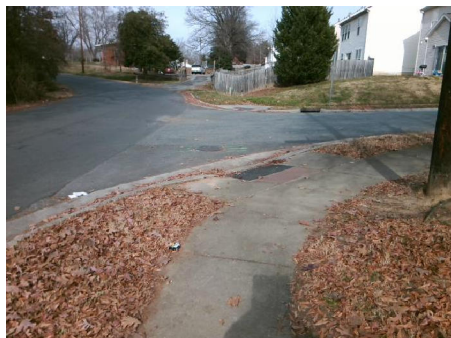
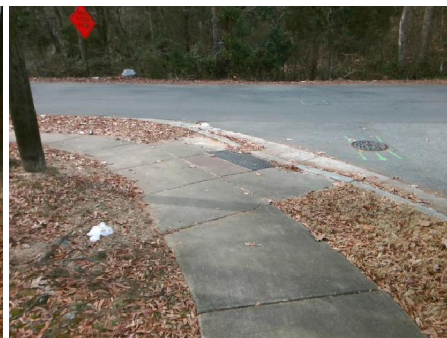
N/A	Ramp inside XWalk1?	N/A	N/A	Ramp inside XWalk2?	N/A
	Road Slope (%)	N/A	N/A	Clear Space?	N/A
	Road X Slope (%)	N/A	N/A	Clear Space to XWalk (in)	N/A
N/A	Any Obstructions?	N/A	N/A	Storm Grate/Utility Hazard?	N/A
	Obstruction Type			Storm Grate/Utility Type	
		N/A			N/A
			Yes	Surface Condition? (G/P)	Good
