Access Compliance Report

Public Rights-of-Way

| Intersection ID: 13414 | Main Street: MCCLINTOCK_RD | Cross Street: ST_JULIEN_ST | Location: W |
| ADA ID: C59EE89BBA06 | Ramp Type: Perp | Initial Pass/Fail: Fail | Overall Compliance: No |

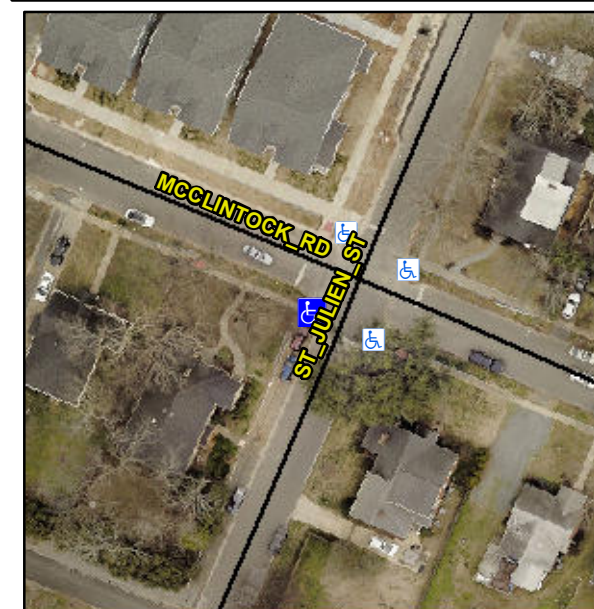
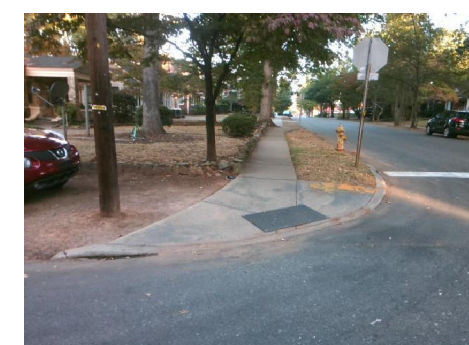
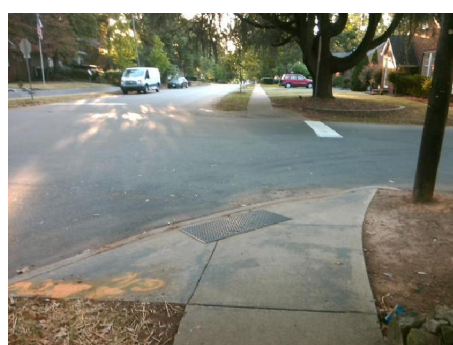
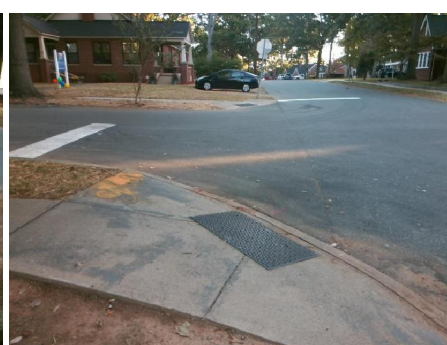
| Severity Score: 13.75 | | | |

Not Found, R304.2.2, R304.5.3

| Compliance | Description | Data | Compliance | Description | Data |
|---|---|---|---|---|---|
| N/A | Ramp Length (in) | 64.5 | No | Ramp Slope (%) | 11.2 |
| Yes | Ramp Width (in) | 60.0 | No | Ramp XSlope (%) | 2.2 |

Remove & Replace Entire Ramp.
