Access Compliance Report

Public Rights-of-Way (Curb Ramps)

Intersection ID: 50710	Main Street: STEELE_CREEK_RD	Cross Street: ARRIVAL_DR	Location: NW
ADA ID: C5DDDB3389090	Ramp Type: Combination1	Initial Pass/Fail: Fail	Overall Compliance: No
			Severity Score: 21.25

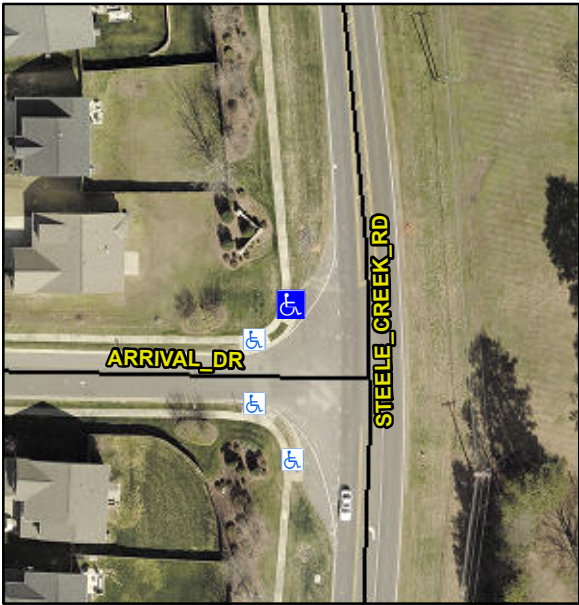
Possible Solutions:			Compliance	Description	Data	Compliance	Description	Data
	Remove & Replace Entire Ramp.			N/A	Ramp Length LT (in)	61.0	N/A	Ramp Length RT (in)	57.5
				No	Ramp Width LT (in)	44.0	No	Ramp Width RT (in)	42.5
				Yes	Ramp Slope LT (%)	8.2	Yes	Ramp Slope RT (%)	6.2
				No	Ramp XSlope LT (%)	3.3	Yes	Ramp XSlope RT (%)	1.6
				N/A	Ramp Length (in)	50.3	Yes	Ramp Slope (%)	8.3
				No	Ramp Width (in)	47.3	No	Ramp XSlope (%)	6.2
				N/A	Flare Type LT	N/A	N/A	Flare Type RT	N/A
				N/A	Flare Slope LT (%)	N/A	N/A	Flare Slope RT (%)	N/A
				N/A	Flare Traversable LT?	N/A	N/A	Flare Traversable RT?	N/A
<p>Surveyor Notes:</p> <p>N/A</p>				N/A	Landing Length (in)	N/A	N/A	DWS Provided?	N/A
				N/A	Landing Width (in)	N/A	N/A	DWS Contrast?	N/A
				N/A	Landing Slope (%)	N/A	N/A	DWS Length (in)	N/A
				N/A	Landing X Slope (%)	N/A	N/A	DWS Full Width?	N/A

N/A	Landing Curb? (Y/N)	N/A	N/A	DWS Offset (in)	N/A
				N/A	Shared Landing?	N/A			
				N/A	Gutter Ponding?	N/A	N/A	Gutter Slope (%)	N/A
				N/A	Gutter Lip Ht (in)	N/A	N/A	Gutter X Slope (%)	N/A
				N/A	Painted X Walk1?	No	N/A	Painted X Walk2?	N/A
					X Walk 1 Direction	To E		X Walk 2 Direction	N/A
<p>PROW/ADA:</p> <p>Not Found, R304.5.1, R304.5.1, R304.5.3</p>					X Walk 1 Width (in)	N/A		X Walk 2 Width (in)	N/A
					X Walk 1 Slope (%)	5.2		X Walk 2 Slope (%)	N/A
					X Walk 1 X Slope (%)	6.2		X Walk 2 X Slope (%)	N/A
				N/A	Ramp inside XWalk1?	N/A	N/A	Ramp inside XWalk2?	N/A
					Road Slope (%)	N/A		Clear Space?	N/A
					Road X Slope (%)	N/A	N/A	Clear Space to XWalk (in)	N/A
							N/A	Any Obstruction?	N/A
								Obstruction Type	N/A
							N/A	Storm Grate/Utility Hazard?	N/A
