# Access Compliance Report

## Public Rights-of-Way

| Intersection ID: 50315 | Main Street: PORTOLA_CT | Cross Street: ESMERALDA_DR | Location: SW |
| ADA ID: C60307935721 | Ramp Type: PerpDiag | Initial Pass/Fail: Pass | Overall Compliance: No |

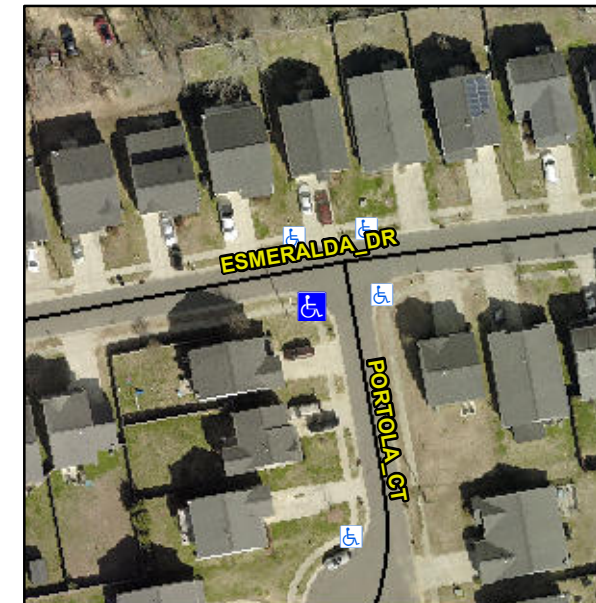
**Not Found, R304.2.1, R304.5.3, R302.7.2, R304.5.4**

| Compliance | Description | Data | Compliance | Description | Data |
|---|---|---|---|---|---|
| No | Landing Length (in) | 47.0 | Yes | DWS Provided? | Yes |
| No | Landing X Slope (%) | 3.4 | Yes | DWS Full Width? | Yes |
| Yes | Gutter Ponding? | No | No | Gutter Slope (%) | 7.6 |
| No | Gutter Lip Ht (in) | 0.8 | Yes | Gutter X Slope (%) | 1.6 |

**Remove & Replace Curb Ramp With Two New Directional Ramps or Equivalent. Remove & Replace Gutter.**
