# Access Compliance Report

## Public Rights-of-Way

### (Curb Ramps)

Intersection ID: 50323	Main Street: SPRECO_LN	Cross Street: WALDON_PARK_LN	Location: E
ADA ID: C60E07630974	Ramp Type: PerpDiag	Initial Pass/Fail: Fail	Overall Compliance: No
			Severity Score: 33.75

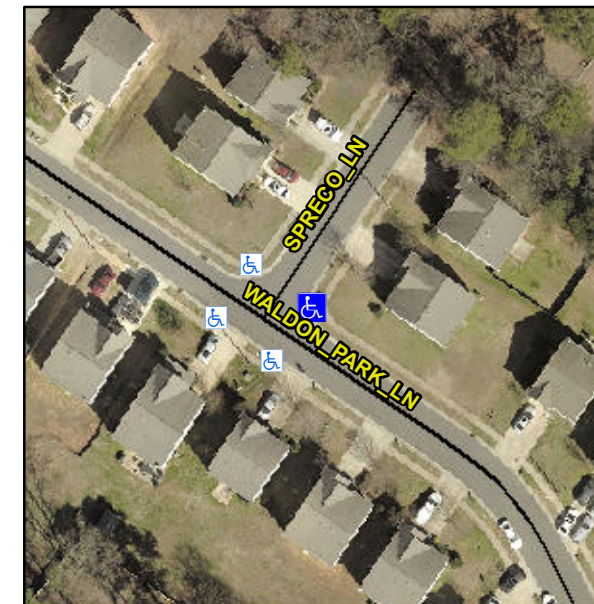
**Not Found, R304.5.1, R304.2.2**

Compliance	Description	Data	Compliance	Description	Data
N/A	Ramp Length (in)	46.0	No	Ramp Slope (%)	13.1
No	Ramp Width (in)	47.0	Yes	Ramp XSlope (%)	0.4
N/A	Flare Type LT	N/A	N/A	Flare Type RT	N/A
N/A	Flare Slope LT (%)	N/A	N/A	Flare Slope RT (%)	N/A
N/A	Flare Traversable LT?	N/A	N/A	Flare Traversable RT?	N/A
N/A	Landing Length (in)	N/A	N/A	DWS Provided?	N/A
N/A	Landing Width (in)	N/A	N/A	DWS Contrast?	N/A
N/A	Landing Slope (%)	N/A	N/A	DWS Length (in)	N/A
N/A	Landing X Slope (%)	N/A	N/A	DWS Full Width?	N/A
N/A	Landing Curb? (Y/N)	N/A	N/A	DWS Offset (in)	N/A
N/A	Shared Landing?	N/A			
N/A	Gutter Ponding?	N/A	N/A	Gutter Slope (%)	N/A
N/A	Gutter Lip Ht (in)	N/A	N/A	Gutter X Slope (%)	N/A
N/A	Painted X Walk1?	No	N/A	Painted X Walk2?	No
	X Walk 1 Direction	To NW		X Walk 2 Direction	To SW
N/A	X Walk 1 Width (in)	N/A	N/A	X Walk 2 Width (in)	N/A
	X Walk 1 Slope (%)	3.9		X Walk 2 Slope (%)	2.7
	X Walk 1 X Slope (%)	2.5		X Walk 2 X Slope (%)	1.7

**Remove & Replace Curb Ramp With Two New Directional Ramps or Equivalent.**
