Access Compliance Report

Public Rights-of-Way

(Curb Ramps)

Intersection ID: 45173	Main Street: LINDEN_TREE_LN	Cross Street: MAPLEHURST_DR	Location: SW
ADA ID: C613B8A5E8A9	Ramp Type: Perp	Initial Pass/Fail: Fail	Overall Compliance: No
		Severity Score: 25

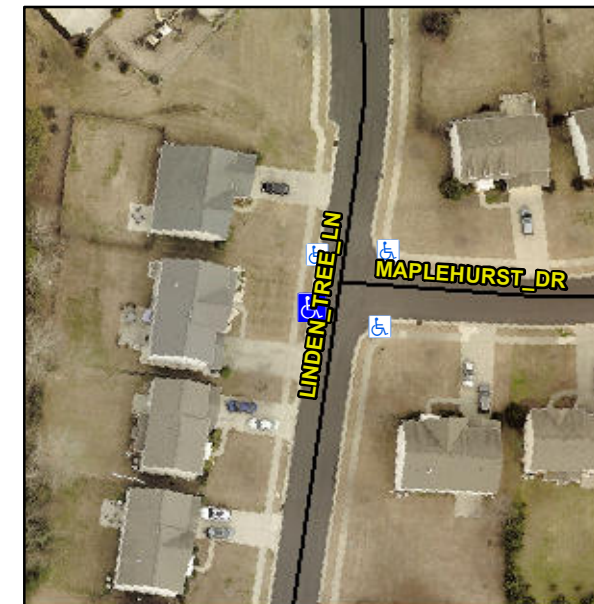
Not Found, R304.2.2

Compliance	Description	Data	Compliance	Description	Data
N/A	Ramp Length (in)	48.0	No	Ramp Slope (%)	13.7
Yes	Ramp Width (in)	48.0	Yes	Ramp XSlope (%)	1.3
N/A	Flare Type LT	N/A	N/A	Flare Type RT	N/A
N/A	Flare Slope LT (%)	N/A	N/A	Flare Slope RT (%)	N/A
N/A	Flare Traversable LT?	N/A	N/A	Flare Traversable RT?	N/A
N/A	Landing Length (in)	N/A	N/A	DWS Provided?	N/A
N/A	Landing Width (in)	N/A	N/A	DWS Contrast?	N/A
N/A	Landing Slope (%)	N/A	N/A	DWS Length (in)	N/A
N/A	Landing X Slope (%)	N/A	N/A	DWS Full Width?	N/A
N/A	Landing Curb? (Y/N)	N/A	N/A	DWS Offset (in)	N/A
N/A	Shared Landing?	N/A			
N/A	Gutter Ponding?	N/A	N/A	Gutter Slope (%)	N/A
N/A	Gutter Lip Ht (in)	N/A	N/A	Gutter X Slope (%)	N/A
N/A	Painted X Walk1?	No	N/A	Painted X Walk2?	N/A
	X Walk 1 Direction	To SE		X Walk 2 Direction	N/A
N/A	X Walk 1 Width (in)	N/A	N/A	X Walk 2 Width (in)	N/A
	X Walk 1 Slope (%)	3.3		X Walk 2 Slope (%)	N/A
	X Walk 1 X Slope (%)	2.0		X Walk 2 X Slope (%)	N/A

Remove & Replace Entire Ramp.
