Access Compliance Report

Public Rights-of-Way

(Curb Ramps)

Intersection ID: 5607	Main Street: DECATUR_CT	Cross Street: HANBERRY_BV	Location:	S
ADA ID: C64B278D2936	Ramp Type: Perp	Initial Pass/Fail: Fail	Overall Compliance: No	Severity Score: 1.25
Codes/Mitigation Info/Possible Solution		Field Measurements/Component Compliance

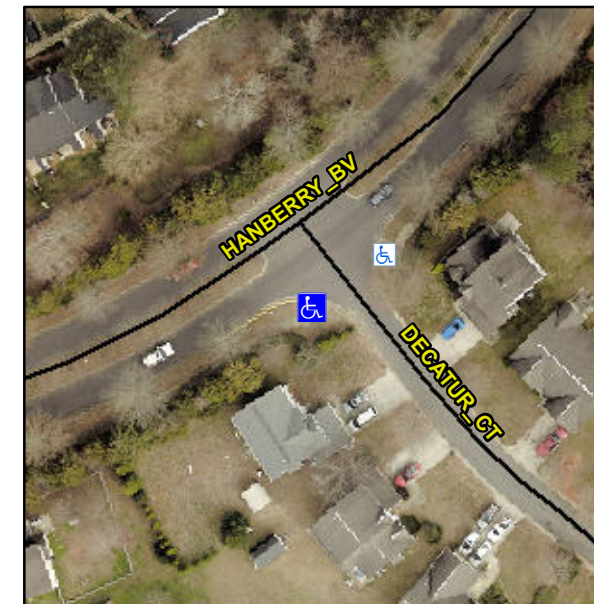
Not Found, R304.5.3

Compliance	Description	Data	Compliance	Description	Data
N/A	Ramp Length (in)	97.0	Yes	Ramp Slope (%)	7.9
Yes	Ramp Width (in)	84.0	No	Ramp XSlope (%)	4.4
N/A	Flare Type LT	N/A	N/A	Flare Type RT	N/A
N/A	Flare Slope LT (%)	N/A	N/A	Flare Slope RT (%)	N/A
N/A	Flare Traversable LT?	N/A	N/A	Flare Traversable RT?	N/A
N/A	Landing Length (in)	N/A	N/A	DWS Provided?	N/A
N/A	Landing Width (in)	N/A	N/A	DWS Contrast?	N/A
N/A	Landing Slope (%)	N/A	N/A	DWS Length (in)	N/A
N/A	Landing X Slope (%)	N/A	N/A	DWS Full Width?	N/A
N/A	Landing Curb? (Y/N)	N/A	N/A	DWS Offset (in)	N/A
N/A	Shared Landing?	N/A			
N/A	Gutter Ponding?	N/A	N/A	Gutter Slope (%)	N/A
N/A	Gutter Lip Ht (in)	N/A	N/A	Gutter X Slope (%)	N/A
N/A	Painted X Walk1?	No	N/A	Painted X Walk2?	N/A
	X Walk 1 Direction	To NE		X Walk 2 Direction	N/A
N/A	X Walk 1 Width (in)	N/A	N/A	X Walk 2 Width (in)	N/A
	X Walk 1 Slope (%)	3.8		X Walk 2 Slope (%)	N/A
	X Walk 1 X Slope (%)	3.3		X Walk 2 X Slope (%)	N/A

Remove & Replace Entire Ramp.
