Access Compliance Report

Public Rights-of-Way

(Curb Ramps)

Intersection ID: 43512	Main Street: BLUEBERRY_HOLLOW_PL	Cross Street: VICTORIA_BROOK_LN	Location: E
ADA ID: C663EDAB50FD	Ramp Type: Perp	Initial Pass/Fail: Fail	Overall Compliance: No
Severity Score: 13.75			
Codes/Mitigation Info/Possible Solution		Field Measurements/Component Compliance

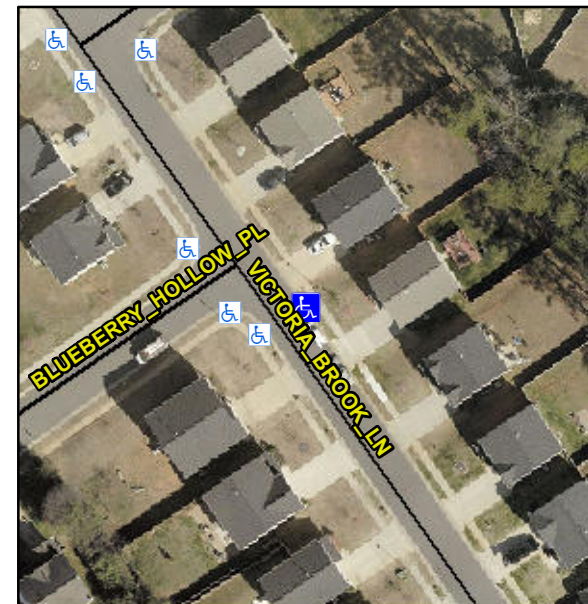
Not Found, R304.2.2

Compliance	Description	Data	Compliance	Description	Data
N/A	Ramp Length (in)	45.0	No	Ramp Slope (%)	8.9
Yes	Ramp Width (in)	48.0	Yes	Ramp XSlope (%)	3.1
N/A	Flare Type LT	N/A	N/A	Flare Type RT	N/A
N/A	Flare Slope LT (%)	N/A	N/A	Flare Slope RT (%)	N/A
N/A	Flare Traversable LT?	N/A	N/A	Flare Traversable RT?	N/A
N/A	Landing Length (in)	N/A	N/A	DWS Provided?	N/A
N/A	Landing Width (in)	N/A	N/A	DWS Contrast?	N/A
N/A	Landing Slope (%)	N/A	N/A	DWS Length (in)	N/A
N/A	Landing X Slope (%)	N/A	N/A	DWS Full Width?	N/A
N/A	Landing Curb? (Y/N)	N/A	N/A	DWS Offset (in)	N/A
N/A	Shared Landing?	N/A			
N/A	Gutter Ponding?	N/A	N/A	Gutter Slope (%)	N/A
N/A	Gutter Lip Ht (in)	N/A	N/A	Gutter X Slope (%)	N/A
N/A	Painted X Walk1?	No	N/A	Painted X Walk2?	N/A
	X Walk 1 Direction	To SW		X Walk 2 Direction	N/A
N/A	X Walk 1 Width (in)	N/A	N/A	X Walk 2 Width (in)	N/A
	X Walk 1 Slope (%)	2.8		X Walk 2 Slope (%)	N/A
	X Walk 1 X Slope (%)	3.2		X Walk 2 X Slope (%)	N/A

Remove & Replace Entire Ramp.

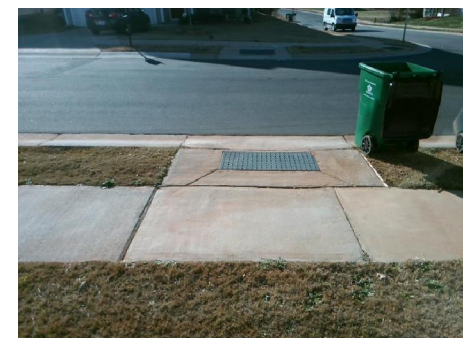
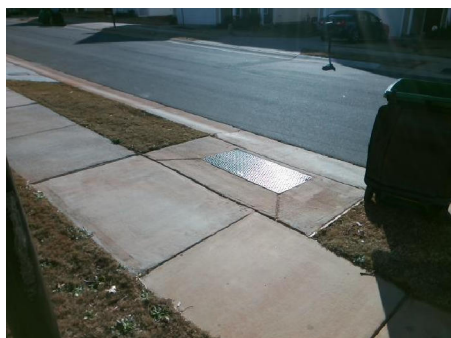
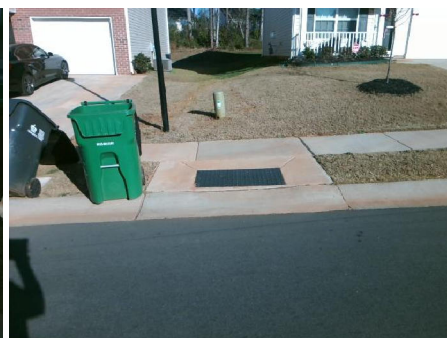
N/A	Ramp inside XWalk1?	N/A	N/A	Ramp inside XWalk2?	N/A
	Road Slope (%)	N/A	N/A	Clear Space?	N/A
	Road X Slope (%)	N/A	N/A	Clear Space to XWalk (in)	N/A
N/A	Any Obstructions?	N/A	N/A	Storm Grate/Utility Hazard?	N/A
	Obstruction Type			Storm Grate/Utility Type	
		N/A			N/A
			Yes	Surface Condition? (G/P)	Good
