# Access Compliance Report

## Public Rights-of-Way

### (Curb Ramps)

Intersection ID: 11921	Main Street: COUNTRY CLUB DR	Cross Street: VENTOSA DR	Location: NW
ADA ID: C672929CBA49	Ramp Type: Perp	Initial Pass/Fail: Fail	Overall Compliance: No
Severity Score: 42.5			
Codes/Mitigation Info/Possible Solution		Field Measurements/Component Compliance

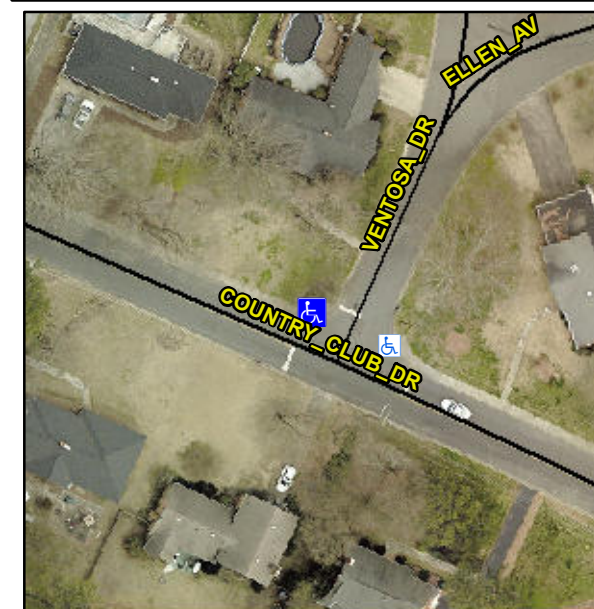
**Not Found, R304.5.1, R304.2.2**

Compliance	Description	Data	Compliance	Description	Data
N/A	Ramp Length (in)	63.0	No	Ramp Slope (%)	14.6
No	Ramp Width (in)	32.0	Yes	Ramp XSlope (%)	0.9
N/A	Flare Type LT	N/A	N/A	Flare Type RT	N/A
N/A	Flare Slope LT (%)	N/A	N/A	Flare Slope RT (%)	N/A
N/A	Flare Traversable LT?	N/A	N/A	Flare Traversable RT?	N/A
N/A	Landing Length (in)	N/A	N/A	DWS Provided?	N/A
N/A	Landing Width (in)	N/A	N/A	DWS Contrast?	N/A
N/A	Landing Slope (%)	N/A	N/A	DWS Length (in)	N/A
N/A	Landing X Slope (%)	N/A	N/A	DWS Full Width?	N/A
N/A	Landing Curb? (Y/N)	N/A	N/A	DWS Offset (in)	N/A
N/A	Shared Landing?	N/A			
N/A	Gutter Ponding?	N/A	N/A	Gutter Slope (%)	N/A
N/A	Gutter Lip Ht (in)	0.5	N/A	Gutter X Slope (%)	N/A
N/A	Painted X Walk1?	No	N/A	Painted X Walk2?	N/A
	X Walk 1 Direction	To SE		X Walk 2 Direction	N/A
N/A	X Walk 1 Width (in)	N/A	N/A	X Walk 2 Width (in)	N/A
	X Walk 1 Slope (%)	1.0		X Walk 2 Slope (%)	N/A
	X Walk 1 X Slope (%)	3.8		X Walk 2 X Slope (%)	N/A

**Remove & Replace Entire Ramp.**
