Access Compliance Report

Public Rights-of-Way

| Intersection ID: 27628 | Main Street: BALLANTYNE COMMONS PY | Cross Street: ADAIR MANOR CT | Location: SW |
| ADA ID: C6BD6CA13270 | Ramp Type: Perp | Initial Pass/Fail: Fail | Overall Compliance: No |

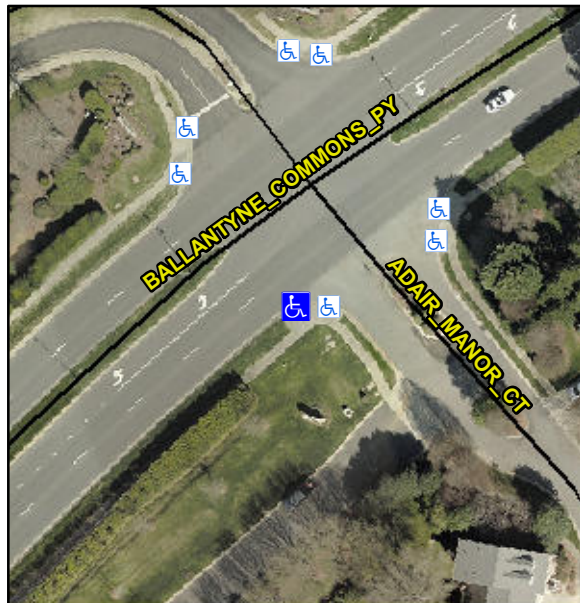
| Severity Score: 17.5 | | | |

R304.5.1

| Compliance | Description | Data | Compliance | Description | Data |
|---|---|---|---|---|---|
| No | Ramp Width (in) | 34.0 | Yes | Ramp XSlope (%) | 2.0 |

Remove & Replace Entire Ramp.
