Access Compliance Report

Public Rights-of-Way

(Curb Ramps)

Intersection ID: 10281	Main Street: CAMPUS_ST	Cross Street: DIXON_ST	Location: NW
ADA ID: C6FC8244669F	Ramp Type: PerpDiag	Initial Pass/Fail: Fail	Overall Compliance: No
			Severity Score: 33.75

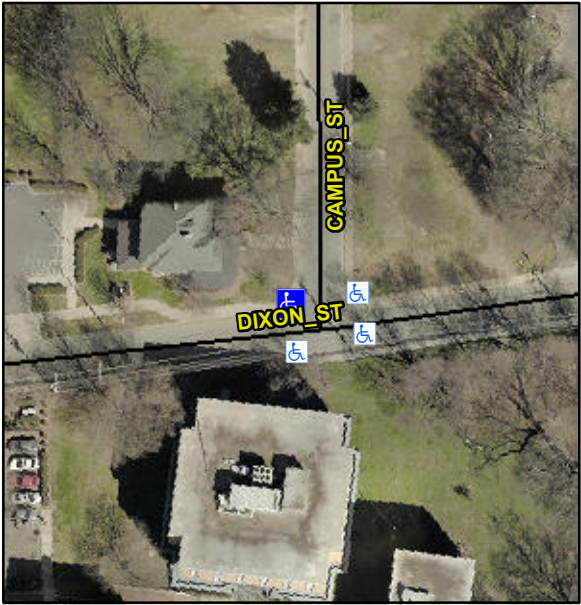
N/A	X Walk 2 Width (in)	N/A
			1.9	X Walk 2 Slope (%)	0.4
			3.9	X Walk 2 X Slope (%)	1.7
			N/A	Ramp inside XWalk2?	N/A
			3.1	Clear Space?	N/A
			0.5	Clear Space to XWalk (in)	N/A
			N/A	Storm Grate/Utility Hazard?	N/A
			N/A	Storm Grate/Utility Type	N/A
			N/A	Surface Condition? (G/P)	Good

Possible Solutions:		Compliance	Description	Data
	Remove & Replace Curb Ramp With Two New Directional Ramps or Equivalent.		No	Ramp Length (in)	46.0
			No	Ramp Width (in)	44.0
			N/A	Flare Type LT	N/A
			N/A	Flare Slope LT (%)	N/A
			N/A	Flare Traversable LT?	N/A
			N/A	Landing Length (in)	N/A
			N/A	Landing Width (in)	N/A
			N/A	Landing Slope (%)	N/A
			N/A	Landing X Slope (%)	N/A
<p>Surveyor Notes:</p> <p>N/A</p> <p>PROW/ADA:</p> <p>Not Found, R304.5.1, R304.2.2, R304.5.3</p>			N/A	Flare Type RT	N/A
			N/A	Flare Slope RT (%)	N/A
			N/A	Flare Traversable RT?	N/A
			N/A	DWS Provided?	N/A
			N/A	DWS Contrast?	N/A
			N/A	DWS Length (in)	N/A
			N/A	DWS Full Width?	N/A
			N/A	DWS Offset (in)	N/A
			N/A	Gutter Ponding?	N/A
			N/A	Gutter Lip Ht (in)	N/A
<p>Total Cost:</p> <p>\$ 3200.00</p>			No	Painted X Walk2?	No
			To S	X Walk 2 Direction	To E
