Access Compliance Report

Public Rights-of-Way

(Curb Ramps)

Intersection ID: 9087	Main Street: WESTERWOOD_DR	Cross Street: WESTERWOOD_VILLAGE_DR	Location: S
ADA ID: C71FFD51444C	Ramp Type: BlendTrans2	Initial Pass/Fail: Fail	Overall Compliance: No
		Severity Score: 25

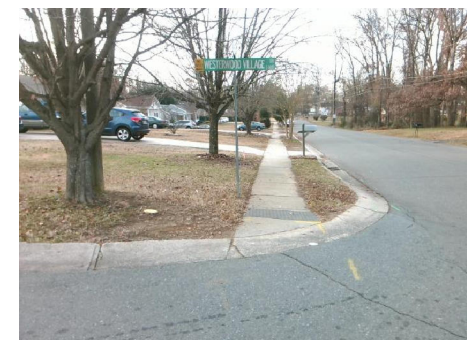
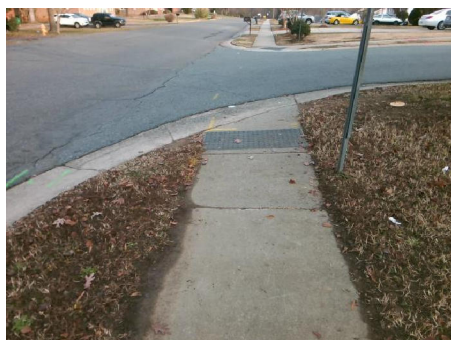
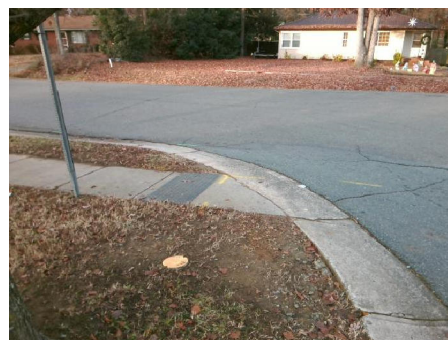
Surveyor Notes:	N/A		N/A	Landing Curb? (Y/N)	N/A	N/A	DWS Offset (in)	N/A
			N/A	Shared Landing?	N/A			
PROW/ADA:			N/A	Gutter Ponding?	N/A	N/A	Gutter Slope (%)	N/A
	R304.5.3		N/A	Gutter Lip Ht (in)	0.5	N/A	Gutter X Slope (%)	N/A
			N/A	Painted X Walk1?	No	N/A	Painted X Walk2?	N/A
				X Walk 1 Direction	To N		X Walk 2 Direction	N/A
				X Walk 1 Width (in)	N/A		X Walk 2 Width (in)	N/A
				X Walk 1 Slope (%)	0.5		X Walk 2 Slope (%)	N/A
				X Walk 1 X Slope (%)	10.1		X Walk 2 X Slope (%)	N/A
			N/A	Ramp inside XWalk1?	N/A	N/A	Ramp inside XWalk2?	N/A
				Road Slope (%)	10.1		Clear Space?	N/A
				Road X Slope (%)	0.5	N/A	Clear Space to XWalk (in)	N/A
			N/A	Any Obstructions?	N/A	N/A	Storm Grate/Utility Hazard?	N/A
				Obstruction Type			Storm Grate/Utility Type	
Total Cost:		\$ 3200.00			N/A			N/A
						Yes	Surface Condition? (G/P)	Good

R304.5.3

Remove & Replace Curb Ramp With Two New Directional Ramps or Equivalent.
