# Access Compliance Report

## Public Rights-of-Way (Curb Ramps)

Intersection ID: 46913	Main Street: PONDEROSA_PINE_LN	Cross Street: PINYON_PINE_LN	Location:	E
ADA ID: C7571EF1ECD7	Ramp Type: PerpDiag	Initial Pass/Fail: Fail	Overall Compliance: No	Severity Score: 25
Codes/Mitigation Info/Possible Solution		Field Measurements/Component Compliance

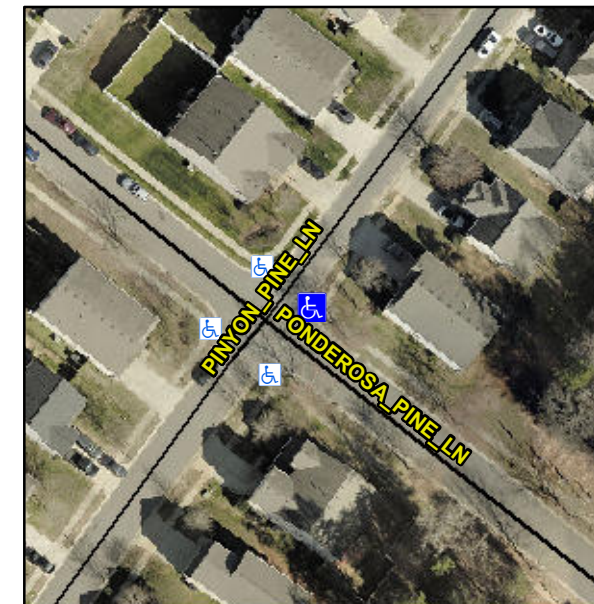
**R304.2.2, R304.5.3**

Compliance	Description	Data	Compliance	Description	Data
N/A	Ramp Length (in)	49.0	No	Ramp Slope (%)	10.3
Yes	Ramp Width (in)	48.0	No	Ramp XSlope (%)	5.6
N/A	Flare Type LT	N/A	N/A	Flare Type RT	N/A
N/A	Flare Slope LT (%)	N/A	N/A	Flare Slope RT (%)	N/A
N/A	Flare Traversable LT?	N/A	N/A	Flare Traversable RT?	N/A
N/A	Landing Length (in)	N/A	N/A	DWS Provided?	N/A
N/A	Landing Width (in)	N/A	N/A	DWS Contrast?	N/A
N/A	Landing Slope (%)	N/A	N/A	DWS Length (in)	N/A
N/A	Landing X Slope (%)	N/A	N/A	DWS Full Width?	N/A
N/A	Landing Curb? (Y/N)	N/A	N/A	DWS Offset (in)	N/A
N/A	Shared Landing?	N/A			
N/A	Gutter Ponding?	N/A	N/A	Gutter Slope (%)	N/A
N/A	Gutter Lip Ht (in)	0.5	N/A	Gutter X Slope (%)	N/A
N/A	Painted X Walk1?	No	N/A	Painted X Walk2?	No
	X Walk 1 Direction	To NW		X Walk 2 Direction	To SW
N/A	X Walk 1 Width (in)	N/A	N/A	X Walk 2 Width (in)	N/A
	X Walk 1 Slope (%)	1.9		X Walk 2 Slope (%)	4.4
	X Walk 1 X Slope (%)	2.6		X Walk 2 X Slope (%)	3.8

N/A	Ramp inside XWalk1?	N/A	N/A	Ramp inside XWalk2?	N/A
	Road Slope (%)	4.1	N/A	Clear Space?	N/A
	Road X Slope (%)	0.2	N/A	Clear Space to XWalk (in)	N/A
N/A	Any Obstructions?	N/A	N/A	Storm Grate/Utility Hazard?	N/A
	Obstruction Type			Storm Grate/Utility Type	
		N/A			N/A
			Yes	Surface Condition? (G/P)	Good

**Remove & Replace Curb Ramp With Two New Directional Ramps or Equivalent.**
