# Access Compliance Report

## Public Rights-of-Way

| Intersection ID: 28147 | Main Street: ARBOR GROVE LN | Cross Street: BENTON PL | Location: W |
| ADA ID: C78CECE2051A | Ramp Type: BlendTrans1 | Initial Pass/Fail: Fail | Overall Compliance: No |

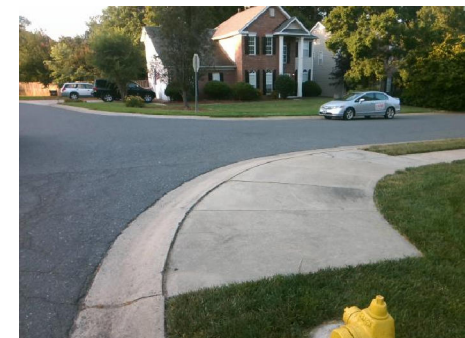
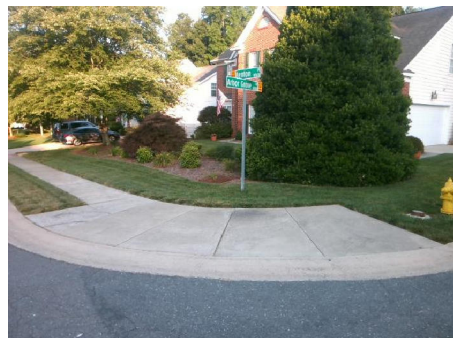
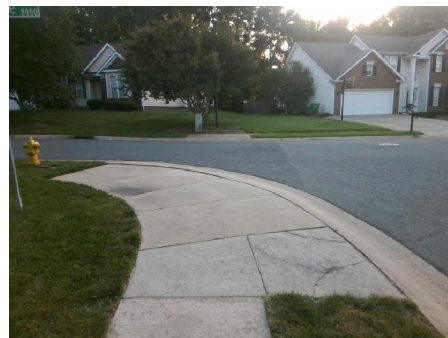
| | | Severity Score: 12.5 | |

**R304.5.3**

| Compliance | Description | Data | Compliance | Description | Data |
|---|---|---|---|---|---|
| Yes | Ramp Width (in) | 96.0 | No | BlendTrans XSlope (%) | 6.4 |

**Remove & Replace Curb Ramp With Two New Directional Ramps or Equivalent.**

Total Cost: \$ 3200.00
