Access Compliance Report

Public Rights-of-Way

(Curb Ramps)

Intersection ID: 11153	Main Street: E_W_T_HARRIS_BV	Cross Street: N_SHARON_AMITY_RD	Location: S
ADA ID: C78F06B56D25	Ramp Type: Combination2	Initial Pass/Fail: Fail	Overall Compliance: No
			Severity Score: 31.25

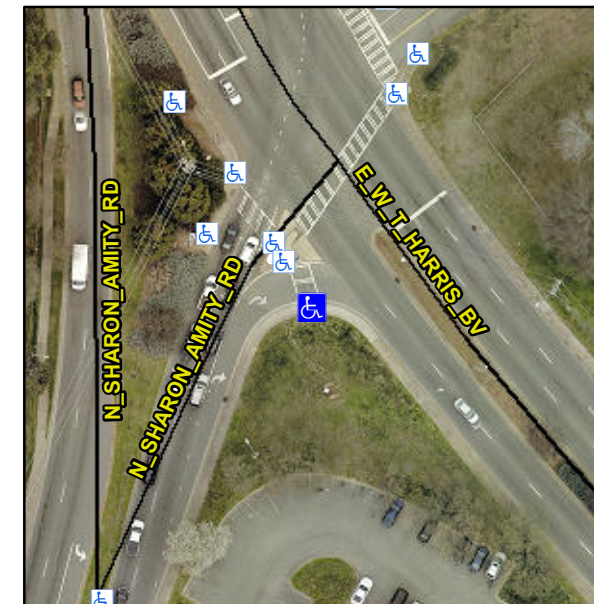
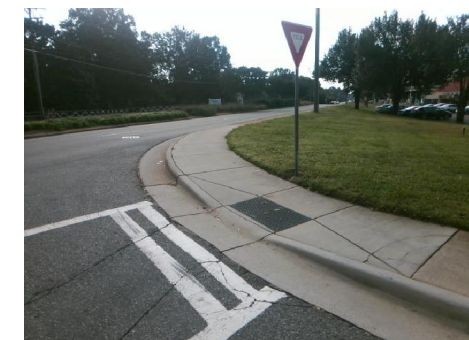
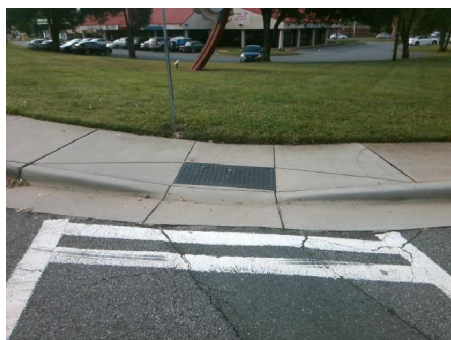
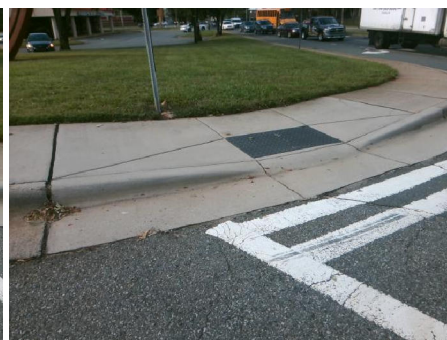
RT RP < 5%

Not Found, R304.5.1, R304.5.3, R304.3.2

Compliance	Description	Data	Compliance	Description	Data
N/A	Ramp Length LT (in)	61.5	N/A	Ramp Length RT (in)	53.0
No	Ramp Width LT (in)	33.0	N/A	Ramp Width RT (in)	35.0
No	Ramp Slope LT (%)	9.5	N/A	Ramp Slope RT (%)	1.6
No	Ramp XSlope LT (%)	2.9	N/A	Ramp XSlope RT (%)	2.5
N/A	Ramp Length (in)	27.5	Yes	Ramp Slope (%)	6.3
Yes	Ramp Width (in)	48.0	No	Ramp XSlope (%)	4.9
N/A	Flare Type LT	N/A	N/A	Flare Type RT	N/A
N/A	Flare Slope LT (%)	N/A	N/A	Flare Slope RT (%)	N/A
N/A	Flare Traversable LT?	N/A	N/A	Flare Traversable RT?	N/A
N/A	Landing Length (in)	N/A	N/A	DWS Provided?	N/A
N/A	Landing Width (in)	N/A	N/A	DWS Contrast?	N/A
N/A	Landing Slope (%)	N/A	N/A	DWS Length (in)	N/A
N/A	Landing X Slope (%)	N/A	N/A	DWS Full Width?	N/A
N/A	Landing Curb? (Y/N)	N/A	N/A	DWS Offset (in)	N/A
N/A	Shared Landing?	N/A			
N/A	Gutter Ponding?	N/A	N/A	Gutter Slope (%)	N/A
N/A	Gutter Lip Ht (in)	N/A	N/A	Gutter X Slope (%)	N/A
N/A	Painted X Walk1?	Yes	N/A	Painted X Walk2?	N/A

Possible Solutions:

Remove & Replace Entire Ramp.
