# Access Compliance Report

## Public Rights-of-Way

### (Curb Ramps)

| Intersection ID: 9339 | Main Street: BADGER_CT | Cross Street: WOODWARD_AV | Location: NE |

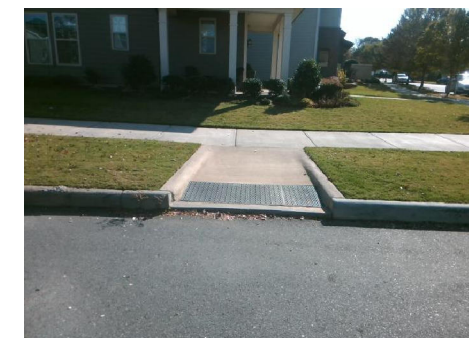
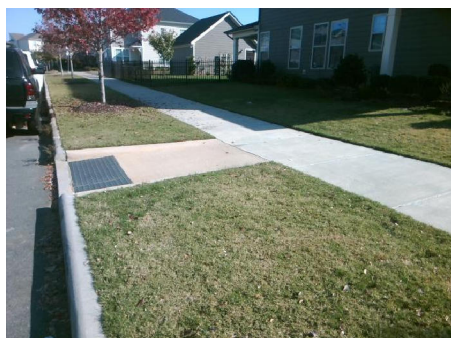
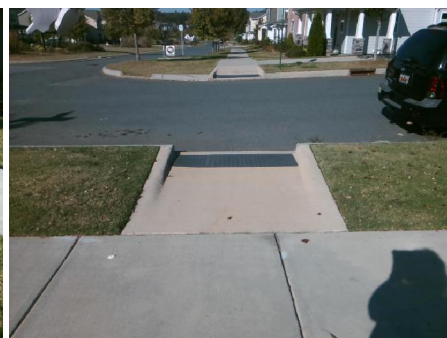
| ADA ID: C79D2D21F172 | Ramp Type: Perp | Initial Pass/Fail: Fail | Overall Compliance: No |

| Compliance | Description | Data | Compliance | Description | Data |
|---|---|---|---|---|---|
| N/A | Ramp Length (in) | 96.0 | No | Ramp Slope (%) | 9.3 |

**Remove & Replace Entire Ramp.**

**R304.2.2**
