Intersection ID: 11499	Main Street: TIMBERTOP_LN	Cross Street: VERONICA_DR	Location:	SE
ADA ID: C7D1A8C11A30	Ramp Type: BlendTrans1	Initial Pass/Fail: Fail	Overall Compliance: No	Severity Score: 10

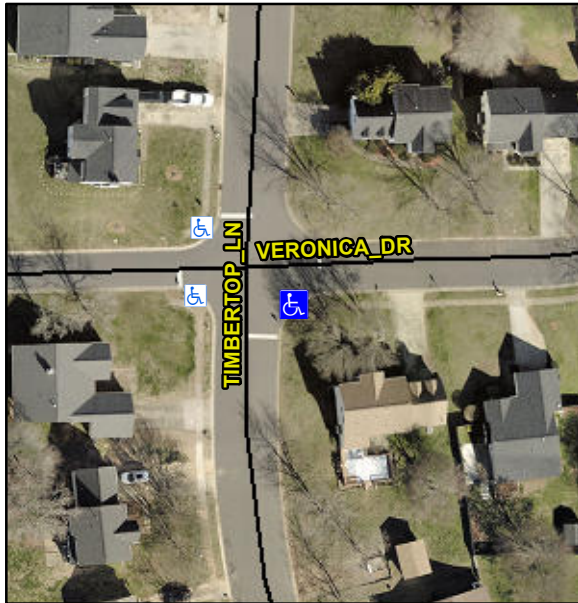
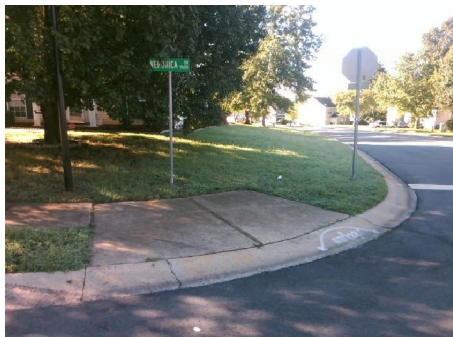
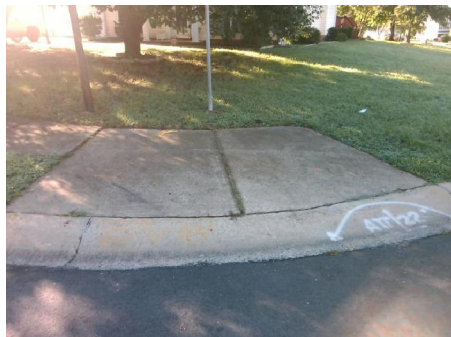
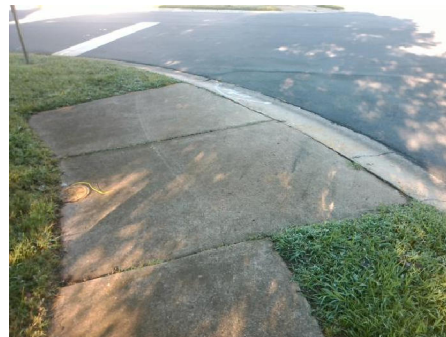
Not Found, R304.5.1, R304.5.3

Compliance	Description	Data	Compliance	Description	Data
N/A	Ramp Length (in)	95.0	Yes	BlendTrans Slope (%)	3.4
No	Ramp Width (in)	47.0	No	BlendTrans XSlope (%)	2.9
N/A	Flare Type LT	N/A	N/A	Flare Type RT	N/A
N/A	Flare Slope LT (%)	N/A	N/A	Flare Slope RT (%)	N/A
N/A	Flare Traversable LT?	N/A	N/A	Flare Traversable RT?	N/A
N/A	Landing Length (in)	N/A	N/A	DWS Provided?	N/A
N/A	Landing Width (in)	N/A	N/A	DWS Contrast?	N/A
N/A	Landing Slope (%)	N/A	N/A	DWS Length (in)	N/A
N/A	Landing X Slope (%)	N/A	N/A	DWS Full Width?	N/A
N/A	Landing Curb? (Y/N)	N/A	N/A	DWS Offset (in)	N/A
N/A	Shared Landing?	N/A			
N/A	Gutter Ponding?	N/A	N/A	Gutter Slope (%)	N/A
N/A	Gutter Lip Ht (in)	N/A	N/A	Gutter X Slope (%)	N/A
N/A	Painted X Walk1?	No	N/A	Painted X Walk2?	N/A
	X Walk 1 Direction	To W		X Walk 2 Direction	N/A
	X Walk 1 Width (in)	N/A		X Walk 2 Width (in)	N/A
	X Walk 1 Slope (%)	1.4		X Walk 2 Slope (%)	N/A
	X Walk 1 X Slope (%)	1.6		X Walk 2 X Slope (%)	N/A

N/A	Ramp inside XWalk1?	N/A	N/A	Ramp inside XWalk2?	N/A
	Road Slope (%)	1.6		Clear Space?	N/A
	Road X Slope (%)	1.4	N/A	Clear Space to XWalk (in)	N/A
N/A	Any Obstructions?	Yes	N/A	Storm Grate/Utility Hazard?	N/A
	Obstruction Type			Storm Grate/Utility Type	
GAS VALVE LIP 1.0					N/A
			Yes	Surface Condition? (G/P)	Good
			No	Curb Slope (%)	11.3

Remove & Replace Curb Ramp With Two New Directional Ramps or Equivalent.
