Access Compliance Report

Public Rights-of-Way

(Curb Ramps)

Intersection ID: 14797	Main Street: LYNDHURST_AV	Cross Street: MAGNOLIA_AV	Location: S
ADA ID: C7DBDD631397	Ramp Type: PerpDiag	Initial Pass/Fail: Fail	Overall Compliance: No
Severity Score: 8.75			
Codes/Mitigation Info/Possible Solution		Field Measurements/Component Compliance

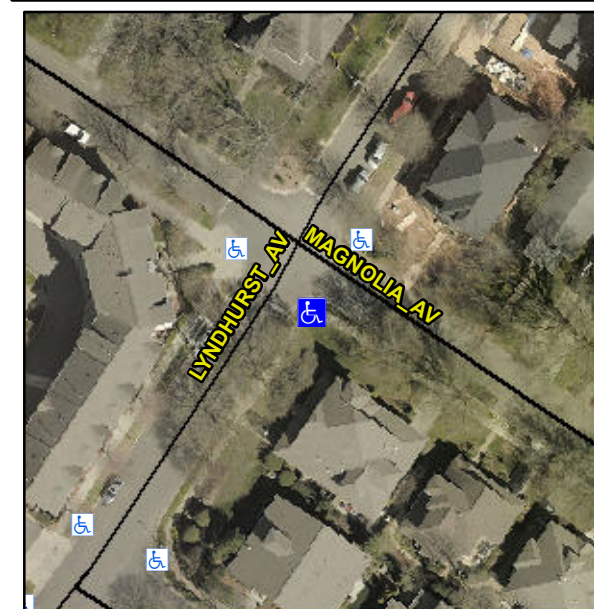
Not Found, R304.5.1

Compliance	Description	Data	Compliance	Description	Data
N/A	Ramp Length (in)	49.0	Yes	Ramp Slope (%)	5.1
No	Ramp Width (in)	47.0	Yes	Ramp XSlope (%)	1.9
N/A	Flare Type LT	N/A	N/A	Flare Type RT	N/A
N/A	Flare Slope LT (%)	N/A	N/A	Flare Slope RT (%)	N/A
N/A	Flare Traversable LT?	N/A	N/A	Flare Traversable RT?	N/A
N/A	Landing Length (in)	N/A	N/A	DWS Provided?	N/A
N/A	Landing Width (in)	N/A	N/A	DWS Contrast?	N/A
N/A	Landing Slope (%)	N/A	N/A	DWS Length (in)	N/A
N/A	Landing X Slope (%)	N/A	N/A	DWS Full Width?	N/A
N/A	Landing Curb? (Y/N)	N/A	N/A	DWS Offset (in)	N/A
N/A	Shared Landing?	N/A			
N/A	Gutter Ponding?	N/A	N/A	Gutter Slope (%)	N/A
N/A	Gutter Lip Ht (in)	N/A	N/A	Gutter X Slope (%)	N/A
N/A	Painted X Walk1?	No	N/A	Painted X Walk2?	No
	X Walk 1 Direction	To NE		X Walk 2 Direction	To NW
N/A	X Walk 1 Width (in)	N/A	N/A	X Walk 2 Width (in)	N/A
	X Walk 1 Slope (%)	1.8		X Walk 2 Slope (%)	0.2
	X Walk 1 X Slope (%)	1.4		X Walk 2 X Slope (%)	0.2

N/A	Ramp inside XWalk1?	N/A	N/A	Ramp inside XWalk2?	N/A
	Road Slope (%)	2.7	N/A	Clear Space?	N/A
	Road X Slope (%)	1.3	N/A	Clear Space to XWalk (in)	N/A
N/A	Any Obstructions?	N/A	N/A	Storm Grate/Utility Hazard?	N/A
	Obstruction Type			Storm Grate/Utility Type	
		N/A			N/A
			Yes	Surface Condition? (G/P)	Good

Possible Solutions:

Remove & Replace Curb Ramp With Two New Directional Ramps or Equivalent.
