Access Compliance Report Public Rights-of-Way (Curb Ramps)

Intersection ID: 47457 Main Street: STEELE CREEK RD **Cross Street: WINGED TEAL RD** Location: NW **Overall Compliance: No Severity Score:** ADA ID: C8096E34F16A Ramp Type: Combination1Diag Initial Pass/Fail: Fail 0

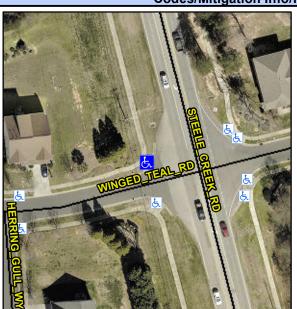
StopSign WINGED TEAL RD None STEELE CREEK RD Possible Solutions: Remove & Replace Curb Ramp With Two New Directional Ramps or Equivalent. Surveyor Notes: LT RP < 5% PROW/ADA Not Found, R304.5.1, R304.5.3, R304.3.2
