# Access Compliance Report

## Public Rights-of-Way

### (Curb Ramps)

| Intersection ID: 23300 | Main Street: SHARON_RD_WEST | Cross Street: SHARONBROOK_DR | Location: S |

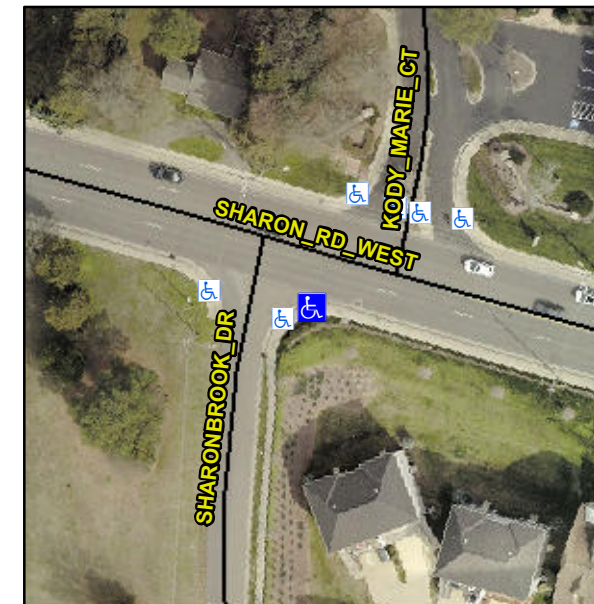
**R304.2.2, R304.5.3**

| Compliance | Description | Data | Compliance | Description | Data |
|---|---|---|---|---|---|
| N/A | Ramp Length (in) | 66.0 | No | Ramp Slope (%) | 15.6 |
| Yes | Ramp Width (in) | 48.0 | No | Ramp XSlope (%) | 3.1 |

**Remove & Replace Entire Ramp.**
