Access Compliance Report

Public Rights-of-Way

(Curb Ramps)

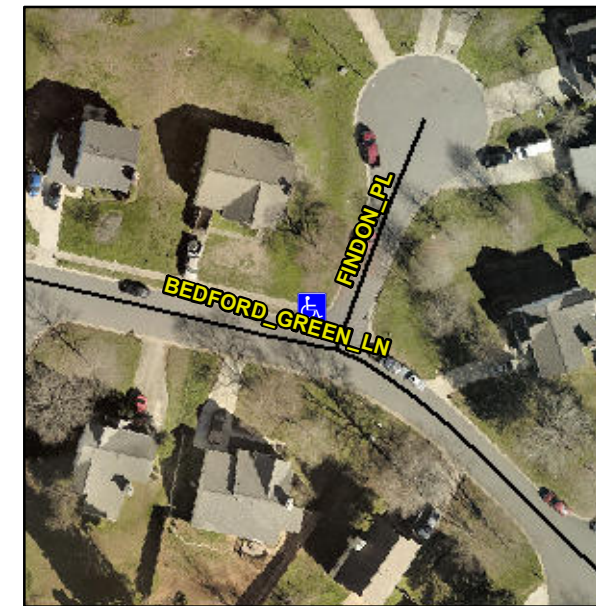
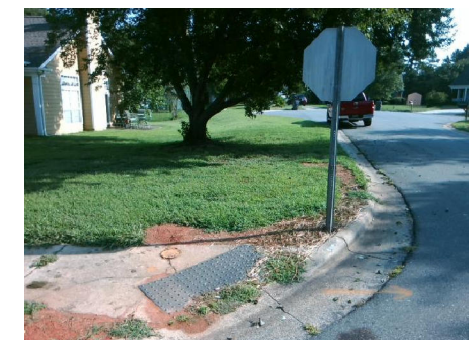
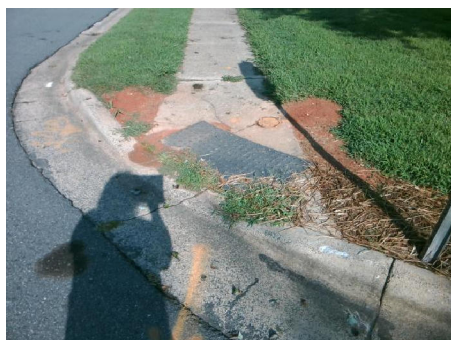
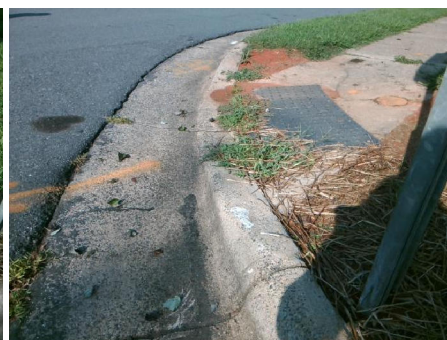
Intersection ID: 9923	Main Street: BEDFORD_GREEN_LN	Cross Street: FINDON_PL	Location:	N
ADA ID: C85B634B6A0B	Ramp Type: Perp	Initial Pass/Fail: Fail	Overall Compliance: No	Severity Score: 10
Codes/Mitigation Info/Possible Solution		Field Measurements/Component Compliance

R304.5.1, R304.5.3

Compliance	Description	Data	Compliance	Description	Data
N/A	Ramp Length (in)	57.0	Yes	Ramp Slope (%)	6.4
No	Ramp Width (in)	42.0	No	Ramp XSlope (%)	4.8
N/A	Flare Type LT	N/A	N/A	Flare Type RT	N/A
N/A	Flare Slope LT (%)	N/A	N/A	Flare Slope RT (%)	N/A
N/A	Flare Traversable LT?	N/A	N/A	Flare Traversable RT?	N/A
N/A	Landing Length (in)	N/A	N/A	DWS Provided?	N/A
N/A	Landing Width (in)	N/A	N/A	DWS Contrast?	N/A
N/A	Landing Slope (%)	N/A	N/A	DWS Length (in)	N/A
N/A	Landing X Slope (%)	N/A	N/A	DWS Full Width?	N/A
N/A	Landing Curb? (Y/N)	N/A	N/A	DWS Offset (in)	N/A
N/A	Shared Landing?	N/A			
N/A	Gutter Ponding?	N/A	N/A	Gutter Slope (%)	N/A
N/A	Gutter Lip Ht (in)	N/A	N/A	Gutter X Slope (%)	N/A
N/A	Painted X Walk1?	No	N/A	Painted X Walk2?	N/A
	X Walk 1 Direction	To SE		X Walk 2 Direction	N/A
N/A	X Walk 1 Width (in)	N/A	N/A	X Walk 2 Width (in)	N/A
	X Walk 1 Slope (%)	4.9		X Walk 2 Slope (%)	N/A
	X Walk 1 X Slope (%)	0.0		X Walk 2 X Slope (%)	N/A

Remove & Replace Entire Ramp.
