Access Compliance Report

Public Rights-of-Way

(Curb Ramps)

| Intersection ID: 46147 | Main Street: ROCKY_FORD_CLUB_RD | Cross Street: ARBOR_CREEK_DR | Location: NW |

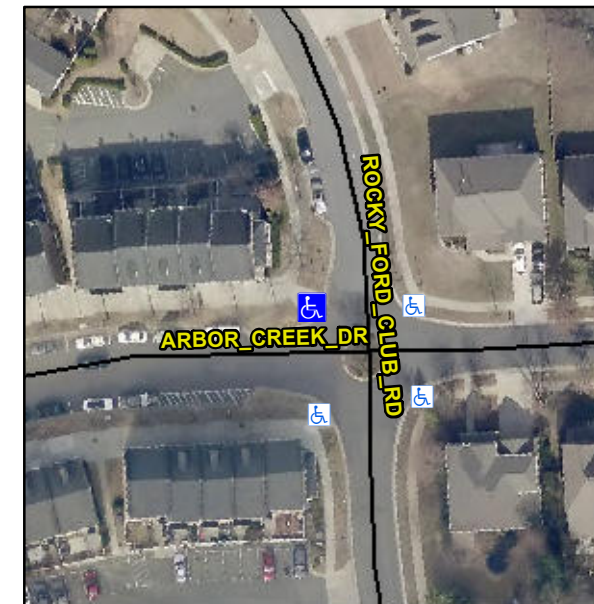
| ADA ID: C93CB31146C5 | Ramp Type: PerpDiag | Initial Pass/Fail: Fail | Overall Compliance: No |
| | | Severity Score: 12.5 | |

| Compliance | Description | Data | Compliance | Description | Data |
|---|---|---|---|---|---|
| N/A | Gutter Ponding? | Yes | N/A | Gutter Slope (%) | N/A |

Remove & Replace Curb Ramp With Two New Directional Ramps or Equivalent.

\$ 3200.00
