Access Compliance Report

Public Rights-of-Way

(Curb Ramps)

Intersection ID: 32298	Main Street: HONEYNUT_DR	Cross Street: LISHA_LN	Location: SE
ADA ID: C95885ADD63D	Ramp Type: PerpDiag	Initial Pass/Fail: Fail	Overall Compliance: No
Severity Score: 13.75			
Codes/Mitigation Info/Possible Solution		Field Measurements/Component Compliance

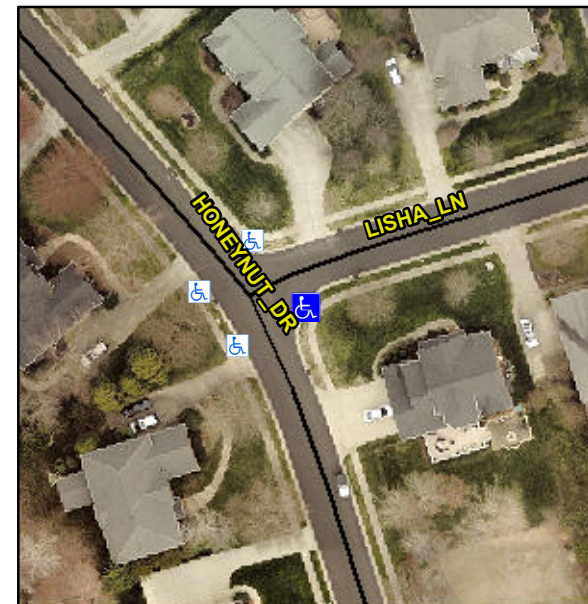
Not Found, R304.2.2, R304.5.3

Compliance	Description	Data	Compliance	Description	Data
N/A	Ramp Length (in)	48.0	No	Ramp Slope (%)	9.8
Yes	Ramp Width (in)	48.0	No	Ramp XSlope (%)	4.2
N/A	Flare Type LT	N/A	N/A	Flare Type RT	N/A
N/A	Flare Slope LT (%)	N/A	N/A	Flare Slope RT (%)	N/A
N/A	Flare Traversable LT?	N/A	N/A	Flare Traversable RT?	N/A
N/A	Landing Length (in)	N/A	N/A	DWS Provided?	N/A
N/A	Landing Width (in)	N/A	N/A	DWS Contrast?	N/A
N/A	Landing Slope (%)	N/A	N/A	DWS Length (in)	N/A
N/A	Landing X Slope (%)	N/A	N/A	DWS Full Width?	N/A
N/A	Landing Curb? (Y/N)	N/A	N/A	DWS Offset (in)	N/A
N/A	Shared Landing?	N/A			
N/A	Gutter Ponding?	N/A	N/A	Gutter Slope (%)	N/A
N/A	Gutter Lip Ht (in)	N/A	N/A	Gutter X Slope (%)	N/A
N/A	Painted X Walk1?	No	N/A	Painted X Walk2?	No
	X Walk 1 Direction	To NW		X Walk 2 Direction	To SW
N/A	X Walk 1 Width (in)	N/A	N/A	X Walk 2 Width (in)	N/A
	X Walk 1 Slope (%)	1.3		X Walk 2 Slope (%)	0.2
	X Walk 1 X Slope (%)	2.8		X Walk 2 X Slope (%)	0.8

Remove & Replace Curb Ramp With Two New Directional Ramps or Equivalent.

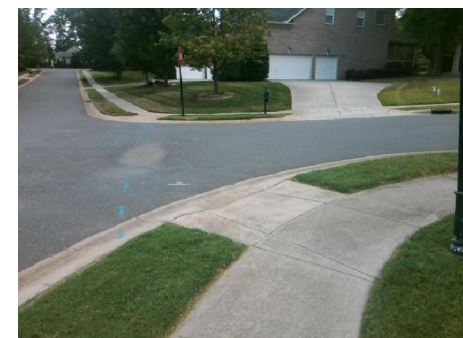
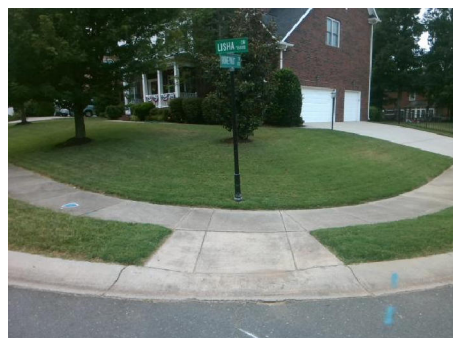
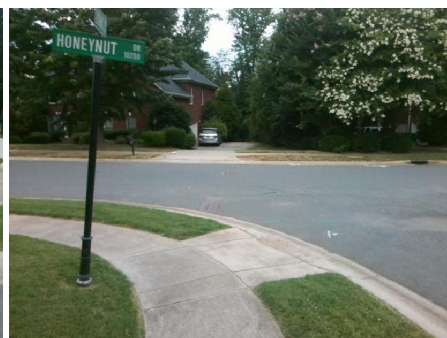
N/A	Ramp inside XWalk1?	N/A	N/A	Ramp inside XWalk2?	N/A
	Road Slope (%)	2.3	N/A	Clear Space?	N/A
	Road X Slope (%)	1.3	N/A	Clear Space to XWalk (in)	N/A
N/A	Any Obstructions?	N/A	N/A	Storm Grate/Utility Hazard?	N/A
	Obstruction Type			Storm Grate/Utility Type	
		N/A			N/A
		Yes		Surface Condition? (G/P)	Good
