Access Compliance Report

Public Rights-of-Way

(Curb Ramps)

Intersection ID: 11037	Main Street: SUMTER_AV	Cross Street: WESTBROOK_DR	Location:	N
ADA ID: C98AD9BD53F1	Ramp Type: PerpDiag	Initial Pass/Fail: Fail	Overall Compliance: No	Severity Score: 47.5
Codes/Mitigation Info/Possible Solution		Field Measurements/Component Compliance

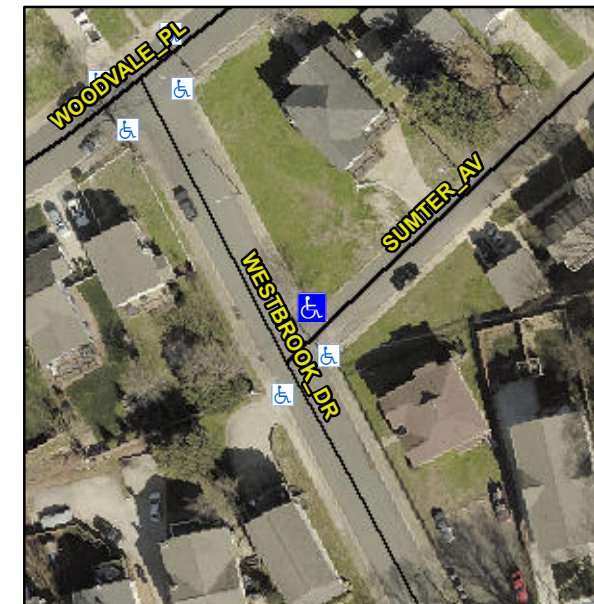
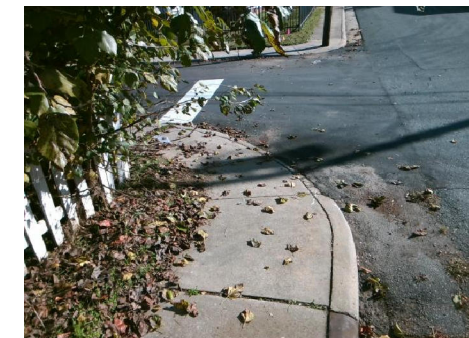
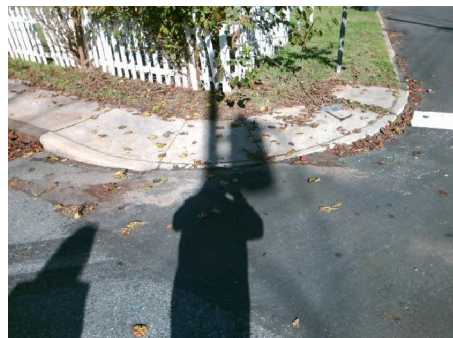
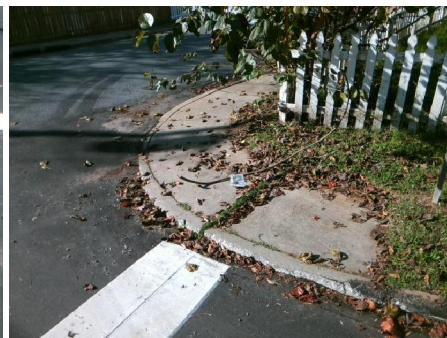
Not Found, R304.5.1, R304.2.2

Compliance	Description	Data	Compliance	Description	Data
N/A	Ramp Length (in)	56.0	No	Ramp Slope (%)	8.8
No	Ramp Width (in)	30.0	Yes	Ramp XSlope (%)	0.3
N/A	Flare Type LT	N/A	N/A	Flare Type RT	N/A
N/A	Flare Slope LT (%)	N/A	N/A	Flare Slope RT (%)	N/A
N/A	Flare Traversable LT?	N/A	N/A	Flare Traversable RT?	N/A
N/A	Landing Length (in)	N/A	N/A	DWS Provided?	N/A
N/A	Landing Width (in)	N/A	N/A	DWS Contrast?	N/A
N/A	Landing Slope (%)	N/A	N/A	DWS Length (in)	N/A
N/A	Landing X Slope (%)	N/A	N/A	DWS Full Width?	N/A
N/A	Landing Curb? (Y/N)	N/A	N/A	DWS Offset (in)	N/A
N/A	Shared Landing?	N/A			
N/A	Gutter Ponding?	N/A	N/A	Gutter Slope (%)	N/A
N/A	Gutter Lip Ht (in)	N/A	N/A	Gutter X Slope (%)	N/A
N/A	Painted X Walk1?	No	N/A	Painted X Walk2?	No
	X Walk 1 Direction	To W		X Walk 2 Direction	To S
N/A	X Walk 1 Width (in)	N/A	N/A	X Walk 2 Width (in)	N/A
	X Walk 1 Slope (%)	1.8		X Walk 2 Slope (%)	2.3
	X Walk 1 X Slope (%)	0.3		X Walk 2 X Slope (%)	1.8

N/A	Ramp inside XWalk1?	N/A	N/A	Ramp inside XWalk2?	N/A
	Road Slope (%)	0.7	N/A	Clear Space?	N/A
	Road X Slope (%)	5.7	N/A	Clear Space to XWalk (in)	N/A
N/A	Any Obstructions?	N/A	N/A	Storm Grate/Utility Hazard?	N/A
	Obstruction Type			Storm Grate/Utility Type	
		N/A			N/A
			Yes	Surface Condition? (G/P)	Good

Remove & Replace Curb Ramp With Two New Directional Ramps or Equivalent.
