Access Compliance Report

Public Rights-of-Way

(Curb Ramps)

Intersection ID: 5598	Main Street: MALLARD_CREEK_RD	Cross Street: MALLARD_PARK_DR	Location: W
ADA ID: C9C94253A6F5	Ramp Type: Combination2	Initial Pass/Fail: Fail	Overall Compliance: No
			Severity Score: 13.75

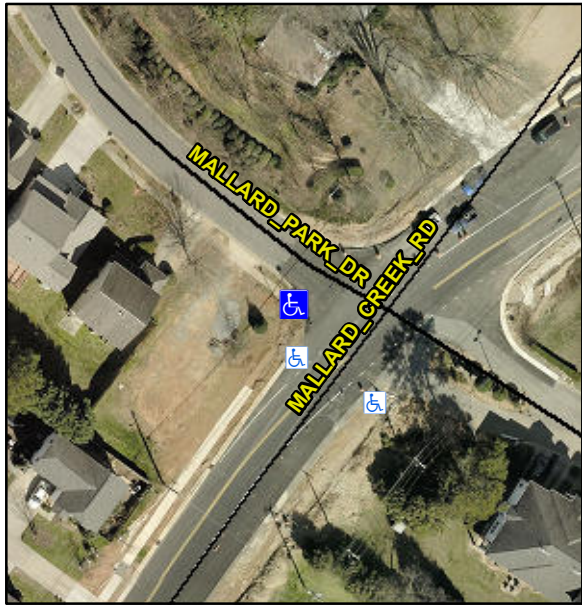
Possible Solutions:			Compliance	Description	Data	Compliance	Description	Data
	Remove & Replace Entire Ramp.			N/A	Ramp Length LT (in)	51.0	N/A	Ramp Length RT (in)	N/A
				Yes	Ramp Width LT (in)	59.0	N/A	Ramp Width RT (in)	N/A
				No	Ramp Slope LT (%)	9.1	N/A	Ramp Slope RT (%)	N/A
				No	Ramp XSlope LT (%)	2.7	N/A	Ramp XSlope RT (%)	N/A
				N/A	Ramp Length (in)	36.0	Yes	Ramp Slope (%)	7.7
				Yes	Ramp Width (in)	48.0	No	Ramp XSlope (%)	4.2
	Surveyor Notes:			N/A	Flare Type LT	N/A	N/A	Flare Type RT	N/A
	N/A			N/A	Flare Slope LT (%)	N/A	N/A	Flare Slope RT (%)	N/A
				N/A	Flare Traversable LT?	N/A	N/A	Flare Traversable RT?	N/A
PROW/ADA:			N/A	Landing Length (in)	N/A	N/A	DWS Provided?	N/A	
Not Found, R304.5.3, R304.3.2			N/A	Landing Width (in)	N/A	N/A	DWS Contrast?	N/A	
			N/A	Landing Slope (%)	N/A	N/A	DWS Length (in)	N/A
