Access Compliance Report

Public Rights-of-Way

(Curb Ramps)

| Intersection ID: 8721 | Main Street: LAUREN_ELIZABETH_CT | Cross Street: STONE_BLUFF_CT | Location: W |

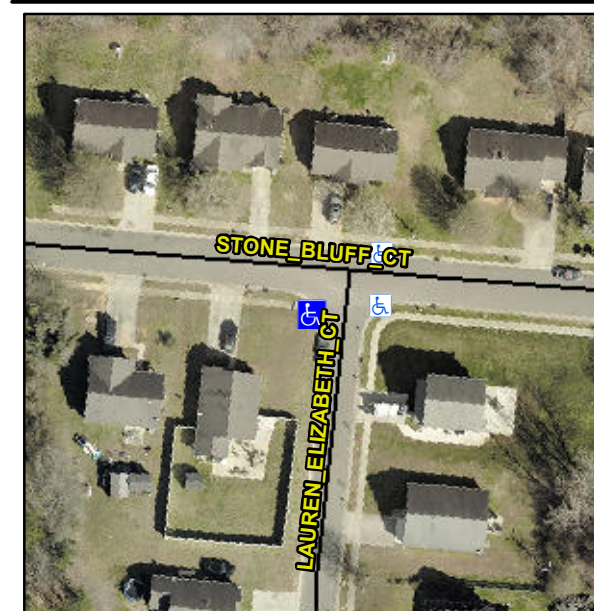
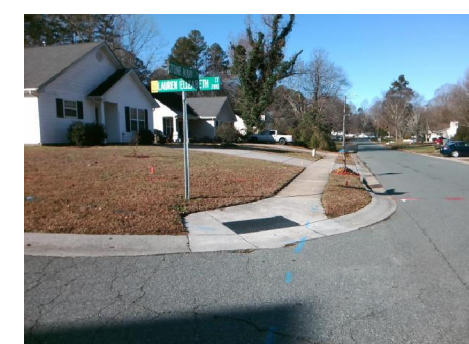
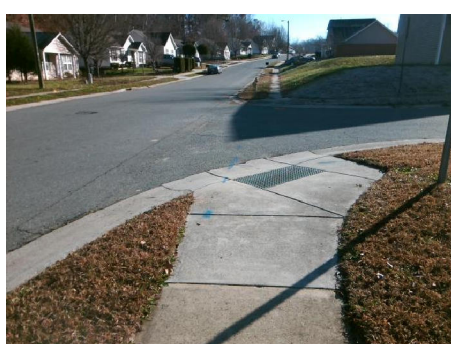
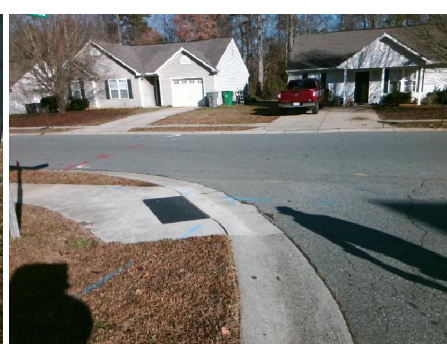
| ADA ID: CA16009ACDF9 | Ramp Type: Perp | Initial Pass/Fail: Fail | Overall Compliance: No |
| Severity Score: 8.75 | | | |

Not Found, R304.5.1

| Compliance | Description | Data | Compliance | Description | Data |
|---|---|---|---|---|---|
| No | Ramp Width (in) | 47.5 | Yes | Ramp XSlope (%) | 1.3 |

Remove & Replace Entire Ramp.
