## **Access Compliance Report Public Rights-of-Way** (Curb Ramps)

Intersection ID: 14336 Main Street: E\_5TH\_ST Cross Street: OSBORNE\_AV Location: SW ADA ID: CA16836545E8 Ramp Type: PerpDiag Initial Pass/Fail: Fail **Overall Compliance: No** Severity Score: 13.75

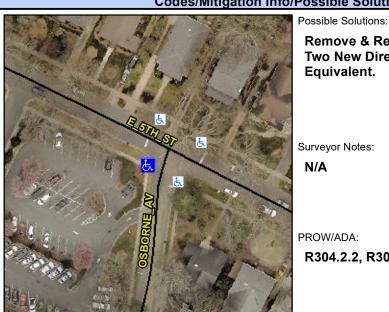
R304.2.2, R304.5.3

Field Measurements/Component Compliance										
	Comp	liance Description	Data	Comp	liance Description	Data				
	N/A	Ramp Length (in)	60.0	No	Ramp Slope (%)	9.2				
	Yes	Ramp Width (in)	48.0	No	Ramp XSlope (%)	4.5				
	N/A	Flare Type LT	N/A	N/A	Flare Type RT	N/A				
	N/A	Flare Slope LT (%)	N/A	N/A	Flare Slope RT (%)	N/A				
	N/A	Flare Traversable LT?	N/A	N/A	Flare Traversable RT?	N/A				
	N/A	Landing Length (in)	N/A	N/A	DWS Provided?	N/A				
	N/A	Landing Width (in)	N/A	N/A	DWS Contrast?	N/A				
	N/A	Landing Slope (%)	N/A	N/A	DWS Length (in)	N/A				
	N/A	Landing X Slope (%)	N/A	N/A	DWS Full Width?	N/A				
	N/A	Landing Curb? (Y/N)	N/A	N/A	DWS Offset (in)	N/A				
	N/A	Shared Landing?	N/A							
	N/A	Gutter Ponding?	N/A	N/A	Gutter Slope (%)	N/A				
	N/A	Gutter Lip Ht (in)	N/A	N/A	Gutter X Slope (%)	N/A				
	N/A	Painted X Walk1?	No	N/A	Painted X Walk2?	No				
		X Walk 1 Direction	To SE		X Walk 2 Direction	To NE

**OSBORNE AV** Street 1 Name Stop Condition-Street 2 StopSign Street 2 Name E 5TH ST Stop Condition-Street 1 StopSign Remove & Replace Curb Ramp With **Two New Directional Ramps or** Equivalent.
