# Access Compliance Report

## Public Rights-of-Way

| Intersection ID: 24329 | Main Street: GARBOW_CT | Cross Street: MIROW_PL | Location: W |
| ADA ID: CA2B800DFBD0 | Ramp Type: Perp | Initial Pass/Fail: Fail | Overall Compliance: No |

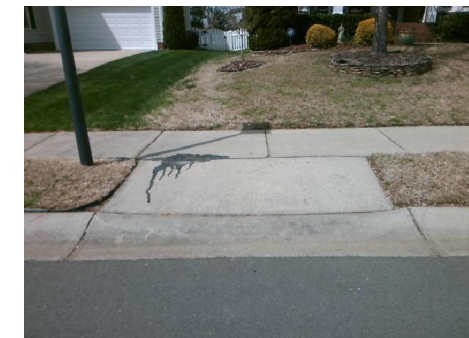
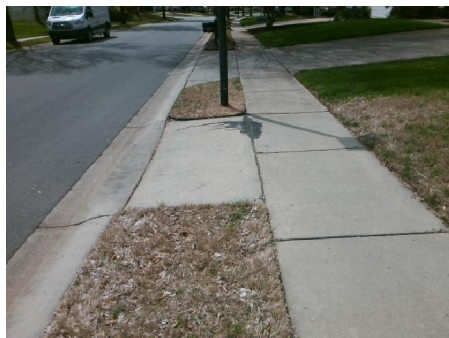
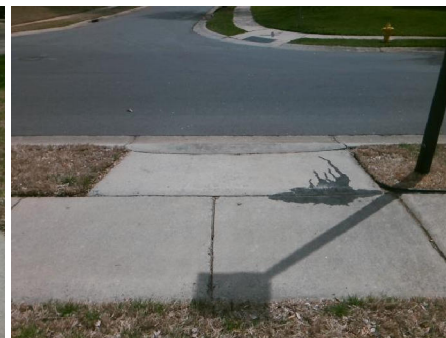
| Severity Score: 13.75 | | | |

**Not Found, R304.2.2, R304.5.3**

| Compliance | Description | Data | Compliance | Description | Data |
|---|---|---|---|---|---|
| N/A | Ramp Length (in) | 48.0 | No | Ramp Slope (%) | 10.1 |
| Yes | Ramp Width (in) | 48.0 | No | Ramp XSlope (%) | 2.6 |

**Remove & Replace Entire Ramp.**

Total Cost: \$ 1850.00
