Access Compliance Report

Public Rights-of-Way

(Curb Ramps)

Intersection ID: 4571	Main Street: LINDEN_BERRY_LN	Cross Street: STREAM_RIDGE_DR	Location: S
ADA ID: CA54179972C0	Ramp Type: Perp	Initial Pass/Fail: Fail	Overall Compliance: No
Severity Score: 13.75			
Codes/Mitigation Info/Possible Solution		Field Measurements/Component Compliance

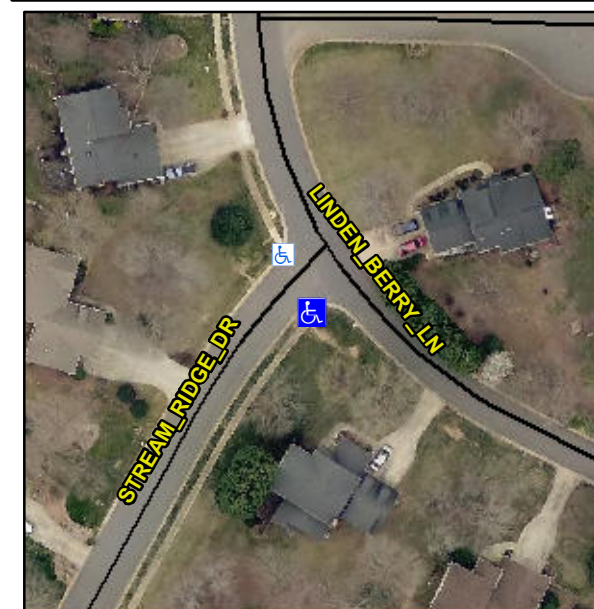
Not Found, R304.2.2, R304.5.3

Compliance	Description	Data	Compliance	Description	Data
N/A	Ramp Length (in)	42.0	No	Ramp Slope (%)	11.8
Yes	Ramp Width (in)	59.5	No	Ramp XSlope (%)	4.0
N/A	Flare Type LT	N/A	N/A	Flare Type RT	N/A
N/A	Flare Slope LT (%)	N/A	N/A	Flare Slope RT (%)	N/A
N/A	Flare Traversable LT?	N/A	N/A	Flare Traversable RT?	N/A
N/A	Landing Length (in)	N/A	N/A	DWS Provided?	N/A
N/A	Landing Width (in)	N/A	N/A	DWS Contrast?	N/A
N/A	Landing Slope (%)	N/A	N/A	DWS Length (in)	N/A
N/A	Landing X Slope (%)	N/A	N/A	DWS Full Width?	N/A
N/A	Landing Curb? (Y/N)	N/A	N/A	DWS Offset (in)	N/A
N/A	Shared Landing?	N/A			
N/A	Gutter Ponding?	N/A	N/A	Gutter Slope (%)	N/A
N/A	Gutter Lip Ht (in)	N/A	N/A	Gutter X Slope (%)	N/A
N/A	Painted X Walk1?	No	N/A	Painted X Walk2?	N/A
	X Walk 1 Direction	To NW		X Walk 2 Direction	N/A
N/A	X Walk 1 Width (in)	N/A	N/A	X Walk 2 Width (in)	N/A
	X Walk 1 Slope (%)	2.3		X Walk 2 Slope (%)	N/A
	X Walk 1 X Slope (%)	5.1		X Walk 2 X Slope (%)	N/A

N/A	Ramp inside XWalk1?	N/A	N/A	Ramp inside XWalk2?	N/A
	Road Slope (%)	N/A	N/A	Clear Space?	N/A
	Road X Slope (%)	N/A	N/A	Clear Space to XWalk (in)	N/A
N/A	Any Obstructions?	N/A	N/A	Storm Grate/Utility Hazard?	N/A
	Obstruction Type			Storm Grate/Utility Type	
		N/A			N/A
			Yes	Surface Condition? (G/P)	Good

Remove & Replace Entire Ramp.

Total Cost: \$ 1850.00
