# Access Compliance Report

## Public Rights-of-Way

### (Curb Ramps)

Intersection ID: 5712	Main Street: BELLHAVEN_BV	Cross Street: GUM_BRANCH_RD	Location:	N
ADA ID: CAAEDBE86F78	Ramp Type: Combination1	Initial Pass/Fail: Fail	Overall Compliance: No	Severity Score: 22.5

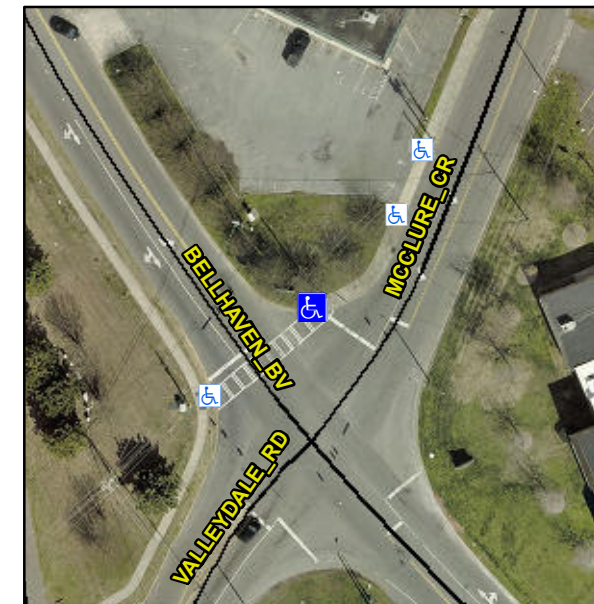
**Not Found, R304.5.1, R304.5.3, R304.3.2**

Compliance	Description	Data	Compliance	Description	Data
N/A	Ramp Length LT (in)	60.0	N/A	Ramp Length RT (in)	62.0
Yes	Ramp Width LT (in)	71.0	Yes	Ramp Width RT (in)	71.0
Yes	Ramp Slope LT (%)	7.7	No	Ramp Slope RT (%)	10.3
No	Ramp XSlope LT (%)	2.9	No	Ramp XSlope RT (%)	4.2
N/A	Ramp Length (in)	71.0	Yes	Ramp Slope (%)	5.0
No	Ramp Width (in)	46.0	Yes	Ramp XSlope (%)	1.8
N/A	Flare Type LT	N/A	N/A	Flare Type RT	N/A
N/A	Flare Slope LT (%)	N/A	N/A	Flare Slope RT (%)	N/A
N/A	Flare Traversable LT?	N/A	N/A	Flare Traversable RT?	N/A
N/A	Landing Length (in)	N/A	N/A	DWS Provided?	N/A
N/A	Landing Width (in)	N/A	N/A	DWS Contrast?	N/A
N/A	Landing Slope (%)	N/A	N/A	DWS Length (in)	N/A
N/A	Landing X Slope (%)	N/A	N/A	DWS Full Width?	N/A
N/A	Landing Curb? (Y/N)	N/A	N/A	DWS Offset (in)	N/A
N/A	Shared Landing?	N/A			
N/A	Gutter Ponding?	N/A	N/A	Gutter Slope (%)	N/A
N/A	Gutter Lip Ht (in)	N/A	N/A	Gutter X Slope (%)	N/A
N/A	Painted X Walk1?	Yes	N/A	Painted X Walk2?	N/A

**Remove & Replace Entire Ramp.**

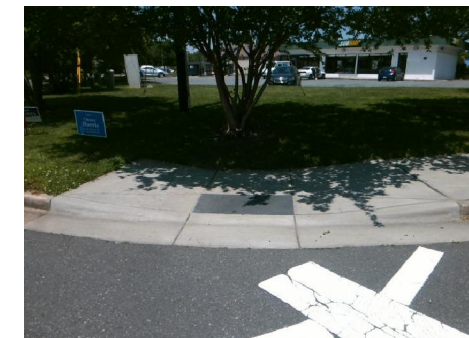
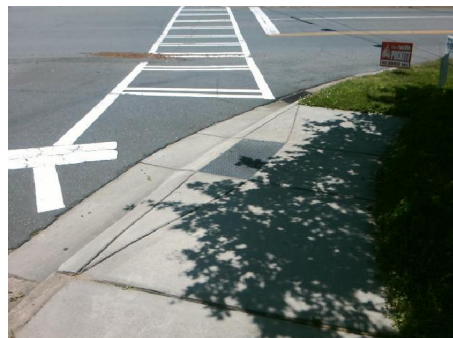
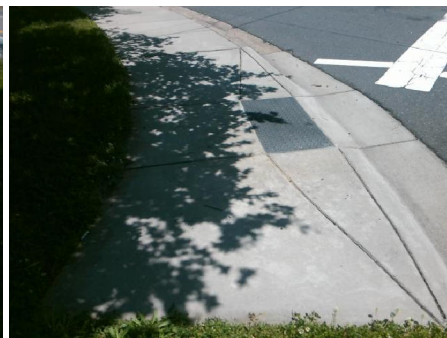
X Walk 1 Direction	To SW		X Walk 2 Direction	N/A
	X Walk 1 Width (in)	95.0		X Walk 2 Width (in)	N/A
	X Walk 1 Slope (%)	2.4		X Walk 2 Slope (%)	N/A
	X Walk 1 X Slope (%)	4.7		X Walk 2 X Slope (%)	N/A
N/A	Ramp inside XWalk1?	Yes	N/A	Ramp inside XWalk2?	N/A
	Road Slope (%)	N/A		Clear Space?	N/A
	Road X Slope (%)	N/A	N/A	Clear Space to XWalk (in)	N/A
			N/A	Any Obstruction?	N/A
				Obstruction Type	N/A
			N/A	Storm Grate/Utility Hazard?	N/A
				Storm Grate/Utility Type	N/A
			Yes	Surface Condition? (G/P)	Good
				Curb Slope (%)	12.1
