| Intersection ID: 27929 | Main Street: GLENN_ABBEY_WY | Cross Street: PROVIDENCE_COUNTRY_CLUB_DR | Location: | NE |
| ADA ID: CAB53B179146 | Ramp Type: Perp | Initial Pass/Fail: Fail | Overall Compliance: No | Severity Score: 1.25 |

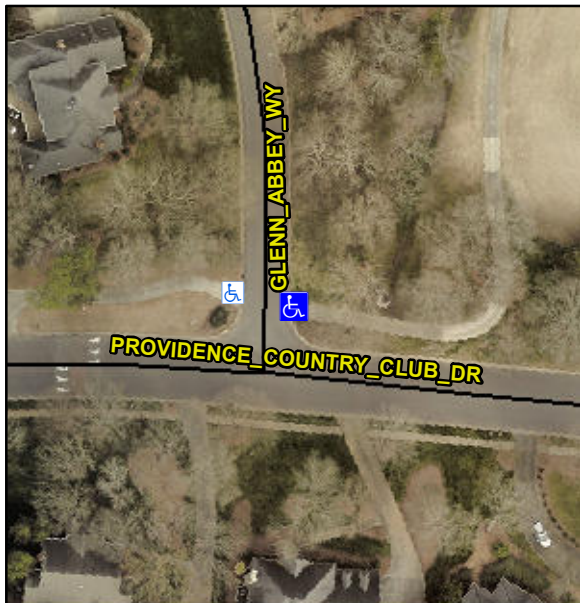
| Codes/Mitigation Info/Possible Solution | | | Field Measurements/Component Compliance | | | | | | |
|--|---|--|--|---|---|---|---|---|---|
| | PROW/ADA: | | Not Found, R304.5.3 | | | | | | |
| | | | Yes | Ramp Width (in) | 48.0 | No | Ramp XSlope (%) | 2.2 | |

| Codes/Mitigation Info/Possible Solution | | | Field Measurements/Component Compliance | | | | | | |
|--|---|--|--|---|---|---|---|---|---|
| | Possible Solutions: | | Remove & Replace Entire Ramp. | | | | | | |
