Access Compliance Report Public Rights-of-Way (Curb Ramps)

Intersection ID: 8672 Main Street: BENNETT_ST Cross Street: HILLSBORO_AV Location: SE **Overall Compliance: No ADA ID: CABC01CF9E8A** Ramp Type: Perp Initial Pass/Fail: Fail **Severity Score:** 22.5

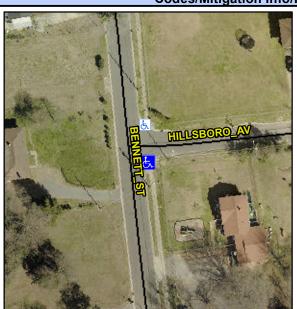
| ١ | |
| - | |
| The state of | Not Found, R304.5.1, R304.2.2, |
| | R304.5.3 |

| Field Measurements/Component Compliance | | | | | | | | | | |
|---|---|---|---|---|---|---|---|--|--|--|
| | N/A | Ramp Length (in) | 70.5 | No | Ramp | Slope (%) | 9.0 | | | |
| | No | Ramp Width (in) | 38.0 | No | Ramp | XSlope (%) | 2.3 | | | |

| | Possible Solutions: |
|---|---|
| é | Remove & Replace Entire Ramp. |
