# Access Compliance Report

## Public Rights-of-Way

### (Curb Ramps)

Intersection ID: 8871	Main Street: NORRIS_AV	Cross Street: ISENHOUR_ST	Location: NW
ADA ID: CB17EB72364F	Ramp Type: Perp	Initial Pass/Fail: Fail	Overall Compliance: No
Codes/Mitigation Info/Possible Solution		Field Measurements/Component Compliance	
Severity Score: 33.75

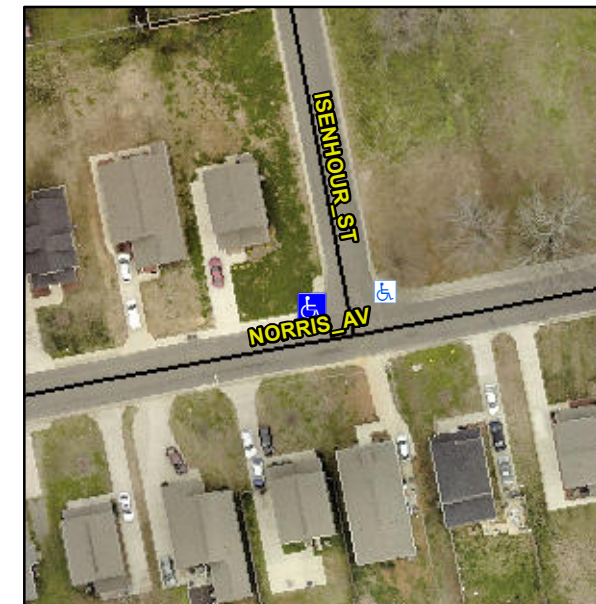
**Not Found, R304.5.1, R304.2.2**

Compliance	Description	Data	Compliance	Description	Data
N/A	Ramp Length (in)	25.5	No	Ramp Slope (%)	12.5
No	Ramp Width (in)	46.5	Yes	Ramp XSlope (%)	0.3
N/A	Flare Type LT	N/A	N/A	Flare Type RT	N/A
N/A	Flare Slope LT (%)	N/A	N/A	Flare Slope RT (%)	N/A
N/A	Flare Traversable LT?	N/A	N/A	Flare Traversable RT?	N/A
N/A	Landing Length (in)	N/A	N/A	DWS Provided?	N/A
N/A	Landing Width (in)	N/A	N/A	DWS Contrast?	N/A
N/A	Landing Slope (%)	N/A	N/A	DWS Length (in)	N/A
N/A	Landing X Slope (%)	N/A	N/A	DWS Full Width?	N/A
N/A	Landing Curb? (Y/N)	N/A	N/A	DWS Offset (in)	N/A
N/A	Shared Landing?	N/A			
N/A	Gutter Ponding?	N/A	N/A	Gutter Slope (%)	N/A
N/A	Gutter Lip Ht (in)	N/A	N/A	Gutter X Slope (%)	N/A
N/A	Painted X Walk1?	No	N/A	Painted X Walk2?	N/A
	X Walk 1 Direction	To E		X Walk 2 Direction	N/A
N/A	X Walk 1 Width (in)	N/A	N/A	X Walk 2 Width (in)	N/A
	X Walk 1 Slope (%)	1.2		X Walk 2 Slope (%)	N/A
	X Walk 1 X Slope (%)	1.4		X Walk 2 X Slope (%)	N/A

**Remove & Replace Entire Ramp.**

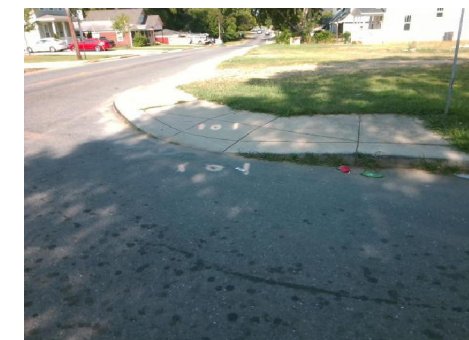
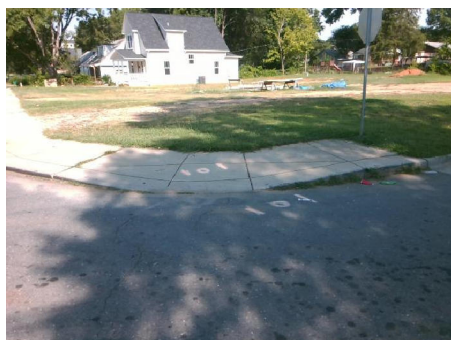
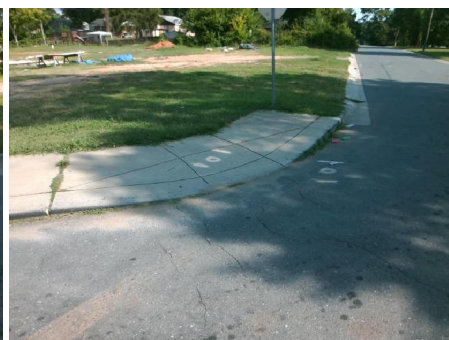
N/A	Ramp inside XWalk1?	N/A	N/A	Ramp inside XWalk2?	N/A
	Road Slope (%)	N/A	N/A	Clear Space?	N/A
	Road X Slope (%)	N/A	N/A	Clear Space to XWalk (in)	N/A
N/A	Any Obstructions?	N/A	N/A	Storm Grate/Utility Hazard?	N/A
	Obstruction Type			Storm Grate/Utility Type	
		N/A			N/A
			Yes	Surface Condition? (G/P)	Good
