# Access Compliance Report

## Public Rights-of-Way

### (Curb Ramps)

| Intersection ID: 48305 | Main Street: MCDONALD_RD | Cross Street: GANSO_LN | Location: NE |

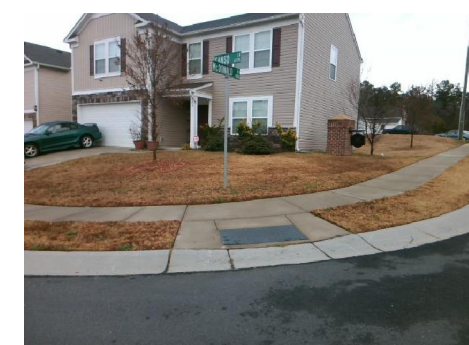
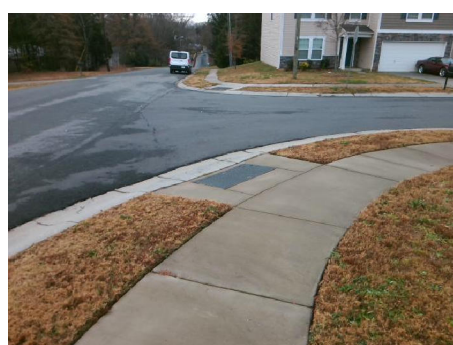
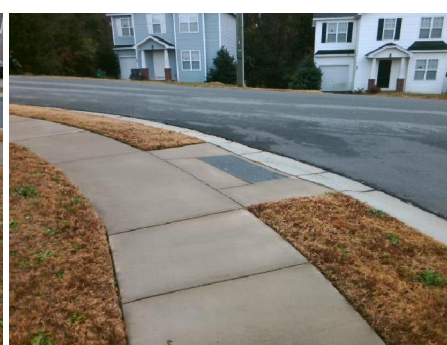
| ADA ID: CB41E0E0966F | Ramp Type: Perp | Initial Pass/Fail: Fail | Overall Compliance: No |
| Severity Score: 13.75 | | | |

**Not Found, R304.2.2, R304.5.3**

| Compliance | Description | Data | Compliance | Description | Data |
|---|---|---|---|---|---|
| N/A | Ramp Length (in) | 48.5 | No | Ramp Slope (%) | 11.3 |
| Yes | Ramp Width (in) | 48.0 | No | Ramp XSlope (%) | 4.5 |

**Remove & Replace Entire Ramp.**
