## **Access Compliance Report Public Rights-of-Way** (Curb Ramps)

Intersection ID: N/A Main Street: LOG CABIN RD **Cross Street: TOM HUNTER RD** Location: SE **Overall Compliance: No Severity Score:** 0 ADA ID: CB461C0ABB06 Ramp Type: Combination2Diag Initial Pass/Fail: Fail

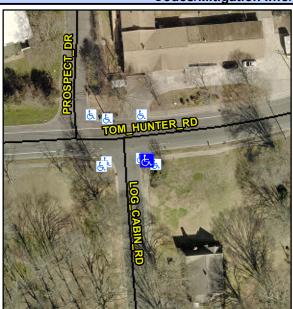
Compliance Description Data Compliance Description N/A N/A Ramp Length LT (in) 31.0 Yes Ramp Width LT (in) 60.0 Yes Yes Ramp Slope LT (%) 1.3 Yes Ramp XSlope LT (%) 2.5 No No N/A Ramp Length (in) 47.0 Yes 35.5 Yes No Ramp Width (in) N/A Flare Type LT N/A N/A N/A N/A Flare Slope LT (%) N/A N/A Flare Traversable LT? N/A N/A N/A Landing Length (in) N/A N/A N/A N/A N/A Landing Width (in) N/A Landing Slope (%) N/A N/A N/A Landing X Slope (%) N/A N/A N/A Landing Curb? (Y/N) N/A N/A N/A Shared Landing? N/A N/A **Gutter Ponding?** N/A N/A N/A N/A Gutter Lip Ht (in) N/A N/A N/A Painted X Walk1? No To N X Walk 1 Direction X Walk 1 Width (in) N/A

None TOM HUNTER RD StopSign LOG CABIN RD Possible Solutions: Remove & Replace Curb Ramp With Two New Directional Ramps or Equivalent. Surveyor Notes: N/A PROW/ADA: Not Found, R304.5.1, R304.5.3
