# Access Compliance Report

## Public Rights-of-Way

| Intersection ID: 13613 | Main Street: HAVENWOOD_RD | Cross Street: KILBORNE_DR | Location: NE |
| ADA ID: CB7922B1BB15 | Ramp Type: Perp | Initial Pass/Fail: Fail | Overall Compliance: No |

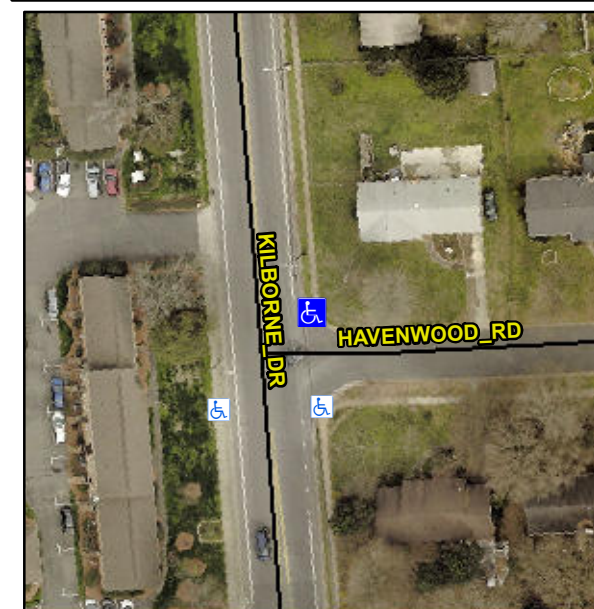
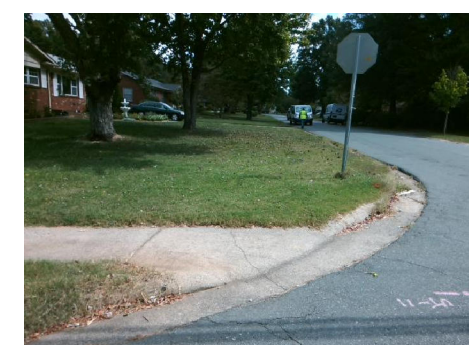
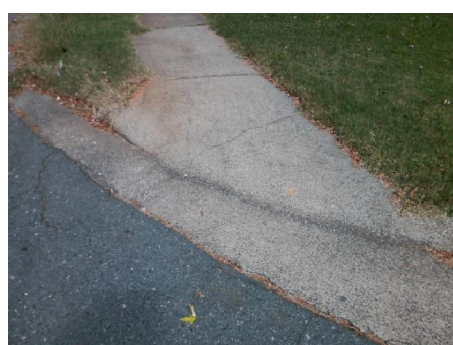
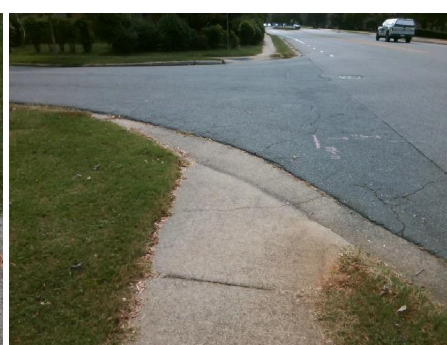
**Not Found, R304.2.2, R304.5.3**

| Compliance | Description | Data | Compliance | Description | Data |
|---|---|---|---|---|---|
| N/A | Ramp Length (in) | 21.0 | No | Ramp Slope (%) | 9.7 |
| Yes | Ramp Width (in) | 52.0 | No | Ramp XSlope (%) | 4.7 |

**Remove & Replace Entire Ramp.**
