# Access Compliance Report

## Public Rights-of-Way

### (Curb Ramps)

Intersection ID: 5623	Main Street: FOREST_SIDE_LN	Cross Street: HANBERRY_BV	Location: SE
ADA ID: CBCCF6095DE6	Ramp Type: PerpDiag	Initial Pass/Fail: Fail	Overall Compliance: No
Severity Score: 1.25			
Codes/Mitigation Info/Possible Solution		Field Measurements/Component Compliance

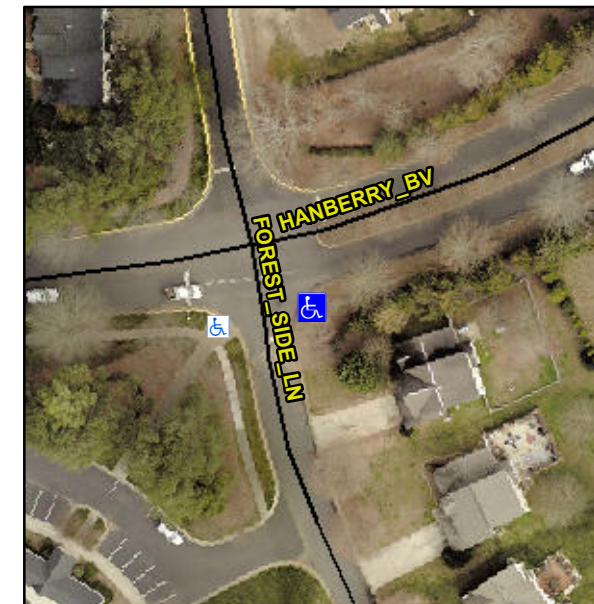
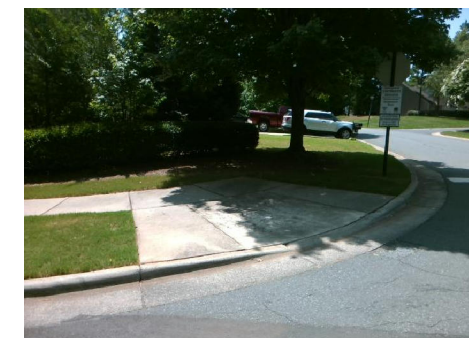
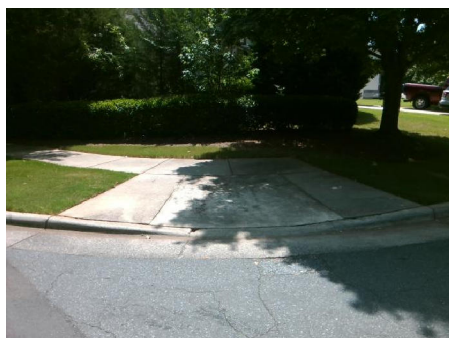
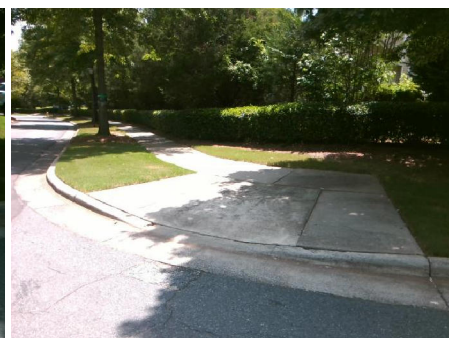
**Not Found, R304.5.3**

Compliance	Description	Data	Compliance	Description	Data
N/A	Ramp Length (in)	96.0	Yes	Ramp Slope (%)	5.0
Yes	Ramp Width (in)	60.0	No	Ramp XSlope (%)	2.8
N/A	Flare Type LT	N/A	N/A	Flare Type RT	N/A
N/A	Flare Slope LT (%)	N/A	N/A	Flare Slope RT (%)	N/A
N/A	Flare Traversable LT?	N/A	N/A	Flare Traversable RT?	N/A
N/A	Landing Length (in)	N/A	N/A	DWS Provided?	N/A
N/A	Landing Width (in)	N/A	N/A	DWS Contrast?	N/A
N/A	Landing Slope (%)	N/A	N/A	DWS Length (in)	N/A
N/A	Landing X Slope (%)	N/A	N/A	DWS Full Width?	N/A
N/A	Landing Curb? (Y/N)	N/A	N/A	DWS Offset (in)	N/A
N/A	Shared Landing?	N/A			
N/A	Gutter Ponding?	N/A	N/A	Gutter Slope (%)	N/A
N/A	Gutter Lip Ht (in)	N/A	N/A	Gutter X Slope (%)	N/A
N/A	Painted X Walk1?	No	N/A	Painted X Walk2?	No
	X Walk 1 Direction	To N		X Walk 2 Direction	To W
N/A	X Walk 1 Width (in)	N/A	N/A	X Walk 2 Width (in)	N/A
	X Walk 1 Slope (%)	0.5		X Walk 2 Slope (%)	4.9
	X Walk 1 X Slope (%)	4.7		X Walk 2 X Slope (%)	0.7

N/A	Ramp inside XWalk1?	N/A	N/A	Ramp inside XWalk2?	N/A
	Road Slope (%)	3.3	N/A	Clear Space?	N/A
	Road X Slope (%)	3.9	N/A	Clear Space to XWalk (in)	N/A
N/A	Any Obstructions?	N/A	N/A	Storm Grate/Utility Hazard?	N/A
	Obstruction Type			Storm Grate/Utility Type	
		N/A			N/A
		Yes		Surface Condition? (G/P)	Good

**Remove & Replace Curb Ramp With Two New Directional Ramps or Equivalent.**
