Access Compliance Report

Public Rights-of-Way

(Curb Ramps)

Intersection ID: 47363	Main Street: JORDAN_PL	Cross Street: MATHESON_AV	Location: SE
ADA ID: CC11862A9DD5	Ramp Type: Combination1	Initial Pass/Fail: Fail	Overall Compliance: No
		Severity Score: 10

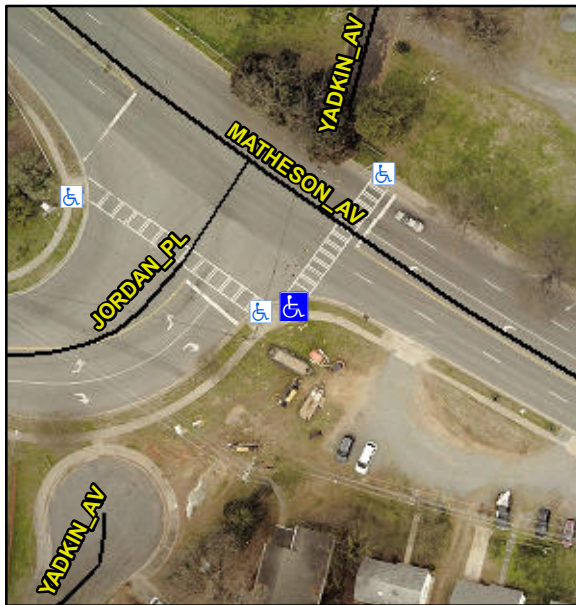
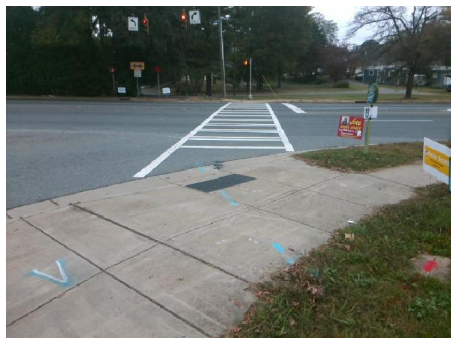
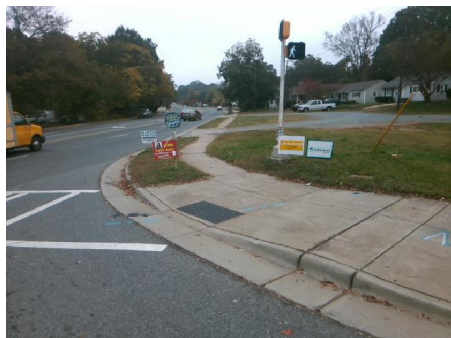
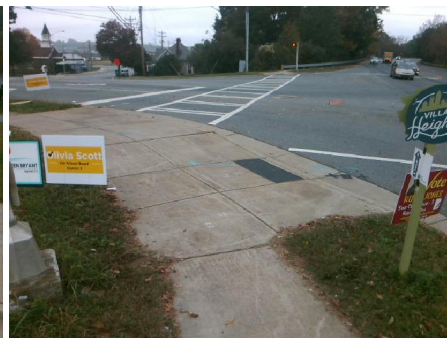
LT RP < 5%

Not Found, R304.5.1, R304.5.3

Compliance	Description	Data	Compliance	Description	Data
N/A	Ramp Length LT (in)	49.0	N/A	Ramp Length RT (in)	60.0
Yes	Ramp Width LT (in)	60.0	Yes	Ramp Width RT (in)	60.0
Yes	Ramp Slope LT (%)	2.2	Yes	Ramp Slope RT (%)	6.6
Yes	Ramp XSlope LT (%)	1.1	Yes	Ramp XSlope RT (%)	0.4
N/A	Ramp Length (in)	67.0	Yes	Ramp Slope (%)	6.6
No	Ramp Width (in)	46.5	No	Ramp XSlope (%)	3.0
N/A	Flare Type LT	N/A	N/A	Flare Type RT	N/A
N/A	Flare Slope LT (%)	N/A	N/A	Flare Slope RT (%)	N/A
N/A	Flare Traversable LT?	N/A	N/A	Flare Traversable RT?	N/A
N/A	Landing Length (in)	N/A	N/A	DWS Provided?	N/A
N/A	Landing Width (in)	N/A	N/A	DWS Contrast?	N/A
N/A	Landing Slope (%)	N/A	N/A	DWS Length (in)	N/A
N/A	Landing X Slope (%)	N/A	N/A	DWS Full Width?	N/A
N/A	Landing Curb? (Y/N)	N/A	N/A	DWS Offset (in)	N/A
N/A	Shared Landing?	N/A			
N/A	Gutter Ponding?	N/A	N/A	Gutter Slope (%)	N/A
N/A	Gutter Lip Ht (in)	N/A	N/A	Gutter X Slope (%)	N/A
N/A	Painted X Walk1?	Yes	N/A	Painted X Walk2?	N/A

X Walk 1 Direction	To NE		X Walk 2 Direction	N/A
	X Walk 1 Width (in)	111.0		X Walk 2 Width (in)	N/A
	X Walk 1 Slope (%)	2.7		X Walk 2 Slope (%)	N/A
	X Walk 1 X Slope (%)	0.8		X Walk 2 X Slope (%)	N/A
N/A	Ramp inside XWalk1?	Yes	N/A	Ramp inside XWalk2?	N/A
	Road Slope (%)	N/A		Clear Space?	N/A
	Road X Slope (%)	N/A	N/A	Clear Space to XWalk (in)	N/A
			N/A	Any Obstruction?	N/A
				Obstruction Type	N/A
			N/A	Storm Grate/Utility Hazard?	N/A
				Storm Grate/Utility Type	N/A
			Yes	Surface Condition? (G/P)	Good
				Curb Slope (%)	17.9

Remove & Replace Entire Ramp.
