Access Compliance Report

Public Rights-of-Way

(Curb Ramps)

Intersection ID: 11331	Main Street: E_W_T_HARRIS_BV	Cross Street: MEADOW_ROSE_LN	Location: NE
ADA ID: CC83804AEB1E	Ramp Type: Combination1	Initial Pass/Fail: Fail	Overall Compliance: No
			Severity Score: 18.75

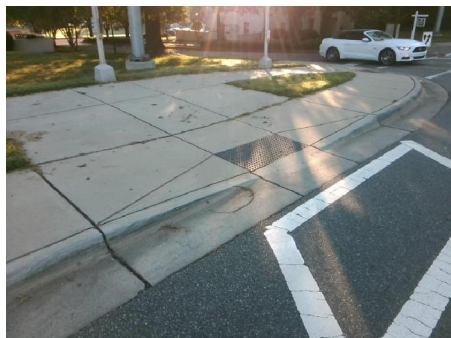
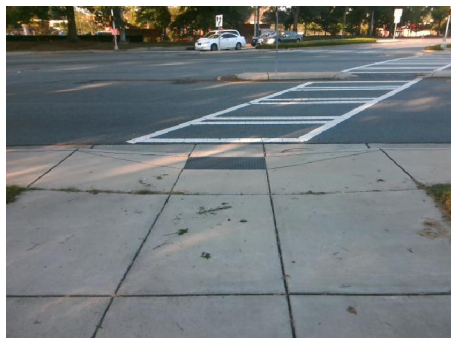
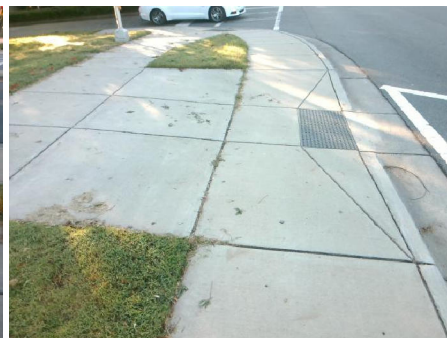
RT RP < 5%

Not Found, R304.5.1, R304.5.3

Compliance	Description	Data	Compliance	Description	Data
N/A	Ramp Length LT (in)	71.0	N/A	Ramp Length RT (in)	68.5
No	Ramp Width LT (in)	34.5	No	Ramp Width RT (in)	34.5
Yes	Ramp Slope LT (%)	7.1	Yes	Ramp Slope RT (%)	2.9
No	Ramp XSlope LT (%)	2.6	Yes	Ramp XSlope RT (%)	1.8
N/A	Ramp Length (in)	25.0	Yes	Ramp Slope (%)	4.4
Yes	Ramp Width (in)	48.0	No	Ramp XSlope (%)	2.3
N/A	Flare Type LT	N/A	N/A	Flare Type RT	N/A
N/A	Flare Slope LT (%)	N/A	N/A	Flare Slope RT (%)	N/A
N/A	Flare Traversable LT?	N/A	N/A	Flare Traversable RT?	N/A
N/A	Landing Length (in)	N/A	N/A	DWS Provided?	N/A
N/A	Landing Width (in)	N/A	N/A	DWS Contrast?	N/A
N/A	Landing Slope (%)	N/A	N/A	DWS Length (in)	N/A
N/A	Landing X Slope (%)	N/A	N/A	DWS Full Width?	N/A
N/A	Landing Curb? (Y/N)	N/A	N/A	DWS Offset (in)	N/A
N/A	Shared Landing?	N/A			
N/A	Gutter Ponding?	N/A	N/A	Gutter Slope (%)	N/A
N/A	Gutter Lip Ht (in)	N/A	N/A	Gutter X Slope (%)	N/A
N/A	Painted X Walk1?	Yes	N/A	Painted X Walk2?	N/A

X Walk 1 Direction	To W		X Walk 2 Direction	N/A
	X Walk 1 Width (in)	112.5		X Walk 2 Width (in)	N/A
	X Walk 1 Slope (%)	2.7		X Walk 2 Slope (%)	N/A
	X Walk 1 X Slope (%)	1.6		X Walk 2 X Slope (%)	N/A
N/A	Ramp inside XWalk1?	Yes	N/A	Ramp inside XWalk2?	N/A
	Road Slope (%)	N/A		Clear Space?	N/A
	Road X Slope (%)	N/A	N/A	Clear Space to XWalk (in)	N/A
			N/A	Any Obstruction?	N/A
				Obstruction Type	N/A
			N/A	Storm Grate/Utility Hazard?	N/A
				Storm Grate/Utility Type	N/A
					N/A
Yes	Surface Condition? (G/P)	Good			
	Curb Slope (%)	10.2

Remove & Replace Entire Ramp.
