# Access Compliance Report

## Public Rights-of-Way

| Intersection ID: 11480 | Main Street: N_CEDAR_ST | Cross Street: W_5TH_ST | Location: E |
| ADA ID: CD67A5B163BD | Ramp Type: PerpDiag | Initial Pass/Fail: Fail | Overall Compliance: No |

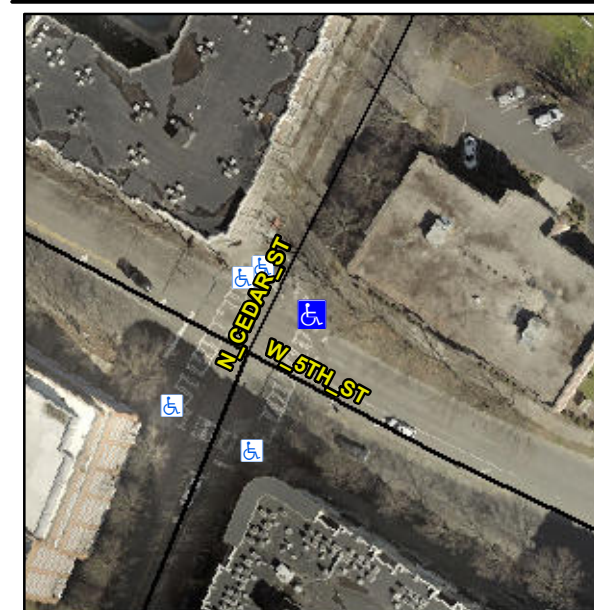
| Severity Score: 42.5 | | | |

**Not Found, R304.5.1, R304.5.3**

| Compliance | Description | Data | Compliance | Description | Data |
|---|---|---|---|---|---|
| No | Ramp Width (in) | 32.0 | No | Ramp XSlope (%) | 11.1 |

**Remove & Replace Curb Ramp With Two New Directional Ramps or Equivalent.**
