# Access Compliance Report

## Public Rights-of-Way

### (Curb Ramps)

Intersection ID: 13781	Main Street: MAYBERRY_LN	Cross Street: ROBINWOOD_DR	Location: NW
ADA ID: CD69C4895DB3	Ramp Type: Perp	Initial Pass/Fail: Fail	Overall Compliance: No
			Severity Score: 13.75

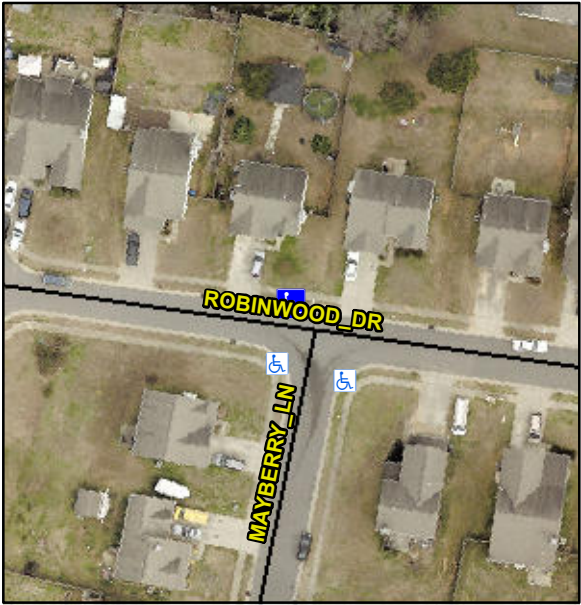
Possible Solutions:		<b>Compliance</b>	<b>Description</b>	<b>Data</b>
	<b>Remove &amp; Replace Entire Ramp.</b>		<b>No</b>	Ramp Length (in)	47.0
			<b>Yes</b>	Ramp Width (in)	48.0
			<b>N/A</b>	Flare Type LT	N/A
			<b>N/A</b>	Flare Slope LT (%)	N/A
			<b>N/A</b>	Flare Traversable LT?	N/A
			<b>N/A</b>	Landing Length (in)	N/A
			<b>N/A</b>	Landing Width (in)	N/A
			<b>N/A</b>	Landing Slope (%)	N/A
			<b>N/A</b>	Landing X Slope (%)	N/A
<p>Surveyor Notes:</p> <p><b>N/A</b></p> <p>PROW/ADA:</p> <p><b>Not Found, R304.2.2</b></p>			<b>N/A</b>	Flare Type RT	N/A
			<b>N/A</b>	Flare Slope RT (%)	N/A
			<b>N/A</b>	Flare Traversable RT?	N/A
			<b>N/A</b>	DWS Provided?	N/A
			<b>N/A</b>	DWS Contrast?	N/A
			<b>N/A</b>	DWS Length (in)	N/A
			<b>N/A</b>	DWS Full Width?	N/A
			<b>N/A</b>	DWS Offset (in)	N/A
			<b>N/A</b>	Shared Landing?	N/A
