Access Compliance Report Public Rights-of-Way (Curb Ramps)

Intersection ID: 43525 Main Street: MILHAVEN_LN Cross Street: TANAGER_PARK_DR Location: SW

ADA ID: CDB650ADB043 Ramp Type: Para Initial Pass/Fail: Fail Overall Compliance: No Severity Score: 12.5

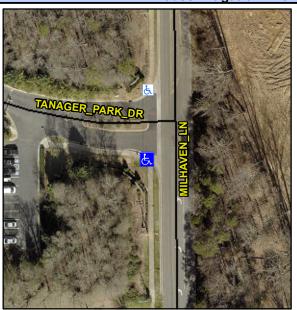
CURB GAP 1.0

R304.3.2

| Compliance Description Data Compliance Description Data | | | | | | |
|---|---|---|---|---|---|---|
| | No | Ramp Slope LT (%) | 9.1 | No | Ramp Slope RT (%) | 9.6 |

Remove & Replace Entire Ramp.
