Access Compliance Report

Public Rights-of-Way

(Curb Ramps)

Intersection ID: 50605	Main Street: DENBUR_DR	Cross Street: RHODORA_RD	Location: SE
ADA ID: CDE004BED675	Ramp Type: Perp	Initial Pass/Fail: Fail	Overall Compliance: No
Severity Score: 13.75			
Codes/Mitigation Info/Possible Solution		Field Measurements/Component Compliance

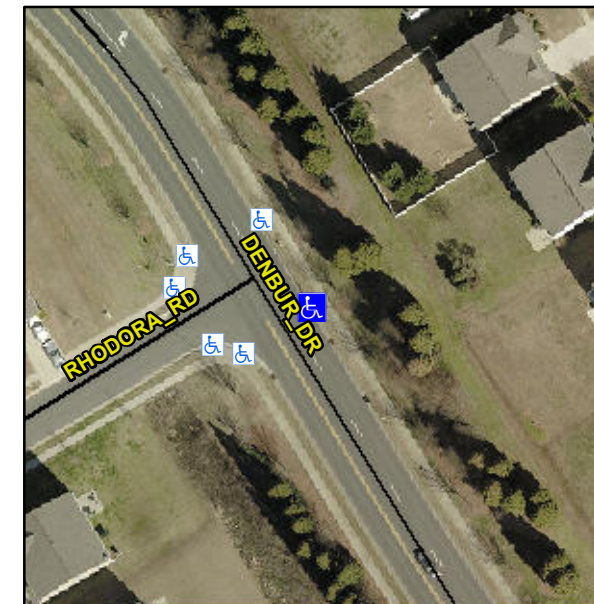
Not Found, R304.2.2

Compliance	Description	Data	Compliance	Description	Data
N/A	Ramp Length (in)	48.5	No	Ramp Slope (%)	10.6
Yes	Ramp Width (in)	49.0	Yes	Ramp XSlope (%)	3.8
N/A	Flare Type LT	N/A	N/A	Flare Type RT	N/A
N/A	Flare Slope LT (%)	N/A	N/A	Flare Slope RT (%)	N/A
N/A	Flare Traversable LT?	N/A	N/A	Flare Traversable RT?	N/A
N/A	Landing Length (in)	N/A	N/A	DWS Provided?	N/A
N/A	Landing Width (in)	N/A	N/A	DWS Contrast?	N/A
N/A	Landing Slope (%)	N/A	N/A	DWS Length (in)	N/A
N/A	Landing X Slope (%)	N/A	N/A	DWS Full Width?	N/A
N/A	Landing Curb? (Y/N)	N/A	N/A	DWS Offset (in)	N/A
N/A	Shared Landing?	N/A			
N/A	Gutter Ponding?	N/A	N/A	Gutter Slope (%)	N/A
N/A	Gutter Lip Ht (in)	N/A	N/A	Gutter X Slope (%)	N/A
N/A	Painted X Walk1?	No	N/A	Painted X Walk2?	N/A
	X Walk 1 Direction	To W		X Walk 2 Direction	N/A
N/A	X Walk 1 Width (in)	N/A	N/A	X Walk 2 Width (in)	N/A
	X Walk 1 Slope (%)	2.6		X Walk 2 Slope (%)	N/A
	X Walk 1 X Slope (%)	4.9		X Walk 2 X Slope (%)	N/A

Remove & Replace Entire Ramp.

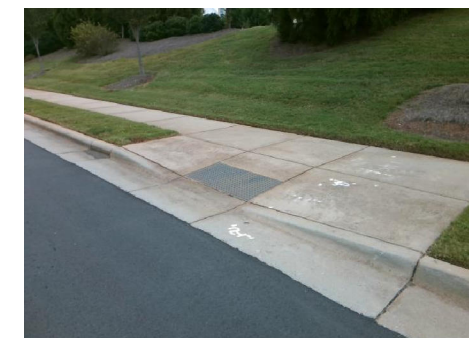
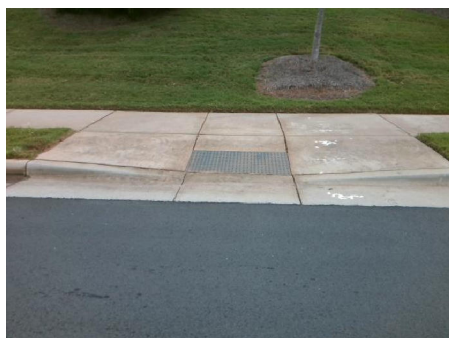
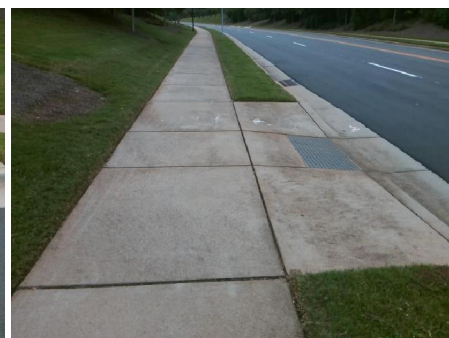
N/A	Ramp inside XWalk1?	N/A	N/A	Ramp inside XWalk2?	N/A
	Road Slope (%)	N/A	N/A	Clear Space?	N/A
	Road X Slope (%)	N/A	N/A	Clear Space to XWalk (in)	N/A
N/A	Any Obstructions?	N/A	N/A	Storm Grate/Utility Hazard?	N/A
	Obstruction Type			Storm Grate/Utility Type	
		N/A			N/A
			Yes	Surface Condition? (G/P)	Good
