Access Compliance Report

Public Rights-of-Way

(Curb Ramps)

Intersection ID: 10029213	Main Street: JOHN_PRICE_RD	Cross Street: N/A	Location: NE
ADA ID: CDE6E03DD877	Ramp Type: Combination1Diag	Initial Pass/Fail: Pass	Overall Compliance: No
		Severity Score: 15

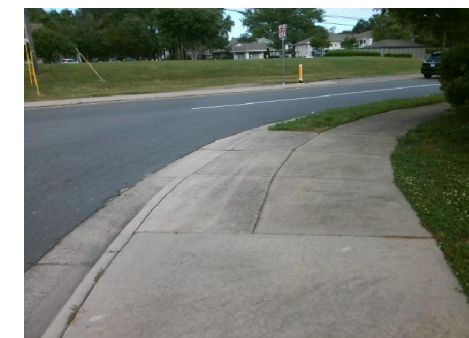
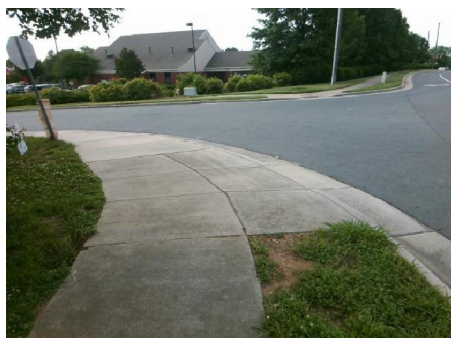
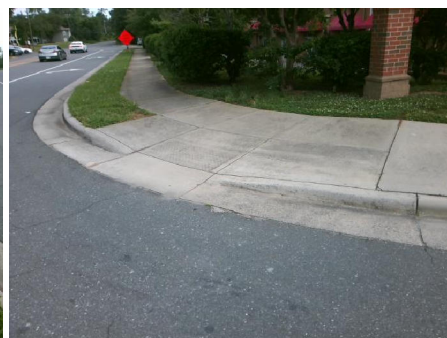
MEDIAN ACROSS JOHN PRICE RD, RT RP < 5%

Not Found, R304.5.3, R304.2.1, R304.2.2-Perp, R304.3.2-Para, R305, R304.5.4

Compliance	Description	Data	Compliance	Description	Data
N/A	Ramp Length LT (in)	55.0	N/A	Ramp Length RT (in)	64.0
Yes	Ramp Width LT (in)	60.0	Yes	Ramp Width RT (in)	60.0
Yes	Ramp Slope LT (%)	6.1	Yes	Ramp Slope RT (%)	1.5
No	Ramp XSlope LT (%)	2.1	Yes	Ramp XSlope RT (%)	1.9
N/A	Ramp Length (in)	51.0	Yes	Ramp Slope (%)	6.7
Yes	Ramp Width (in)	54.0	No	Ramp XSlope (%)	4.6
N/A	Flare Type LT	Sloped	N/A	Flare Type RT	Sloped
N/A	Flare Slope LT (%)	10.6	Yes	Flare Slope RT (%)	2.6
N/A	Flare Traversable LT?	No	N/A	Flare Traversable RT?	Yes
Yes	Landing Length (in)	60.0	No	DWS Provided?	No
No	Landing Width (in)	42.5	N/A	DWS Contrast?	No
No	Landing Slope (%)	2.6	N/A	DWS Length (in)	N/A
No	Landing X Slope (%)	2.3	N/A	DWS Full Width?	No
N/A	Landing Curb? (Y/N)	No	N/A	DWS Offset (in)	N/A
N/A	Shared Landing?	No			
Yes	Gutter Ponding?	No	No	Gutter Slope (%)	7.5
Yes	Gutter Lip Ht (in)	0.0	No	Gutter X Slope (%)	2.1
N/A	Painted X Walk1?	No	N/A	Painted X Walk2?	No

Remove & Replace Curb Ramp With Two New Directional Ramps or Equivalent. Remove & Replace Gutter.
