Access Compliance Report

Public Rights-of-Way

(Curb Ramps)

Intersection ID: 48950	Main Street: DAVID_JENNINGS_AV	Cross Street: BONROI_AV	Location: SW
ADA ID: CE07593F638E	Ramp Type: Combination2	Initial Pass/Fail: Fail	Overall Compliance: No
Codes/Mitigation Info/Possible Solution		Field Measurements/Component Compliance	
Severity Score: 22.5

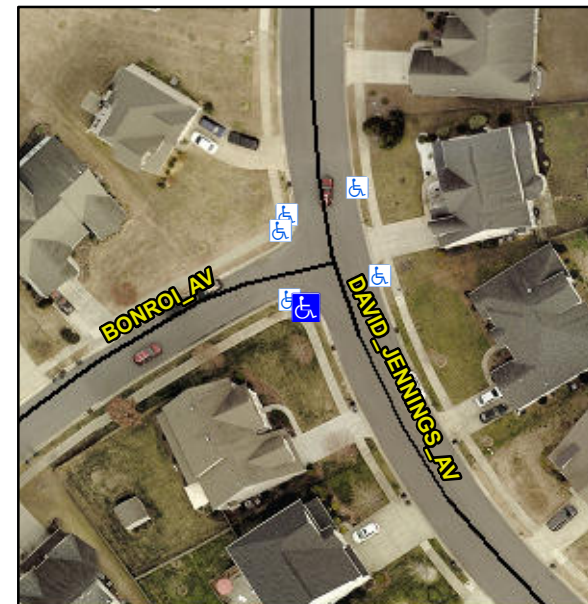
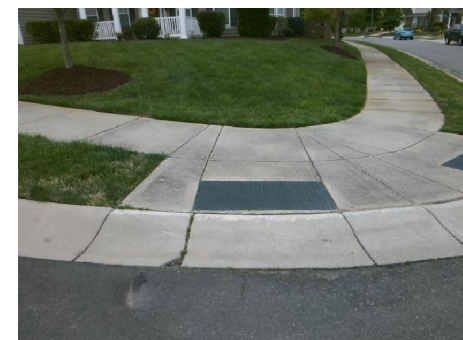
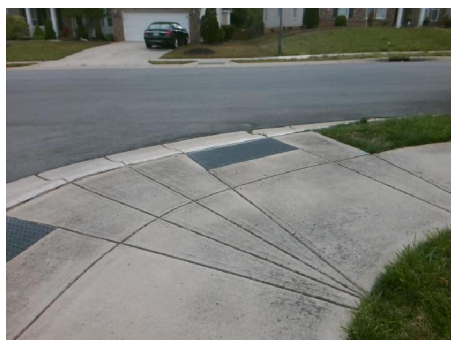
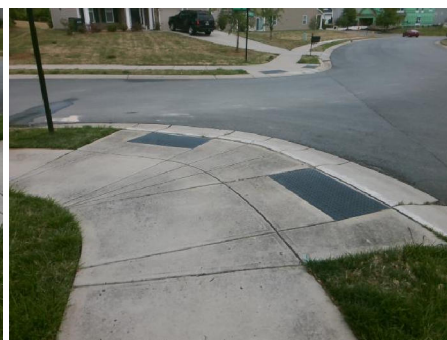
RT RP < 5%

Not Found, R304.5.1, R304.5.3, R304.3.2

Compliance	Description	Data	Compliance	Description	Data
N/A	Ramp Length LT (in)	7.5	N/A	Ramp Length RT (in)	1.0
Yes	Ramp Width LT (in)	58.0	N/A	Ramp Width RT (in)	61.5
No	Ramp Slope LT (%)	10.2	N/A	Ramp Slope RT (%)	4.7
No	Ramp XSlope LT (%)	2.8	N/A	Ramp XSlope RT (%)	2.4
N/A	Ramp Length (in)	47.0	Yes	Ramp Slope (%)	2.8
No	Ramp Width (in)	47.0	No	Ramp XSlope (%)	4.7
N/A	Flare Type LT	N/A	N/A	Flare Type RT	N/A
N/A	Flare Slope LT (%)	N/A	N/A	Flare Slope RT (%)	N/A
N/A	Flare Traversable LT?	N/A	N/A	Flare Traversable RT?	N/A
N/A	Landing Length (in)	N/A	N/A	DWS Provided?	N/A
N/A	Landing Width (in)	N/A	N/A	DWS Contrast?	N/A
N/A	Landing Slope (%)	N/A	N/A	DWS Length (in)	N/A
N/A	Landing X Slope (%)	N/A	N/A	DWS Full Width?	N/A
N/A	Landing Curb? (Y/N)	N/A	N/A	DWS Offset (in)	N/A
N/A	Shared Landing?	N/A			
N/A	Gutter Ponding?	N/A	N/A	Gutter Slope (%)	N/A
N/A	Gutter Lip Ht (in)	N/A	N/A	Gutter X Slope (%)	N/A
N/A	Painted X Walk1?	No	N/A	Painted X Walk2?	N/A

Remove & Replace Entire Ramp.
